Report: TAB Report

Function: Test, Adjust, & Balance

10-20-25 QT #0847 GAINESVILLE, GA

QUIKTRIP

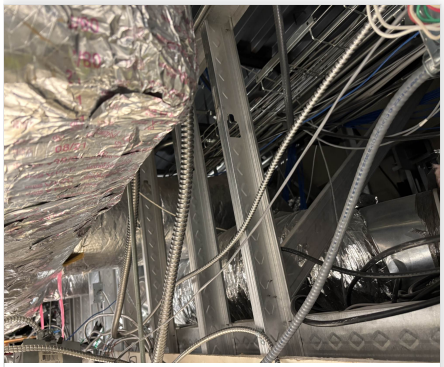
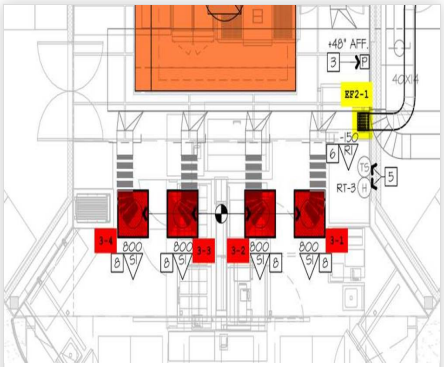
Issue Name : RTU-3: Kitchen Supply Diffuser Ductwork Incorrect

Description : RTU-3 Diffusers 3-1 and 3-4 in the kitchen are not connected to the supply duct. They are still connected to the return duct. This will need to be corrected. RTU 3 is balanced to total design airflow.
