Report: FINAL TAB REPORT
Function: Test, Adjust, & Balance
Date: 10/11/2022

10-03 FREDDY'S HAMPTON, VA

Project: 10-03 FREDDY'S HAMPTON, VA

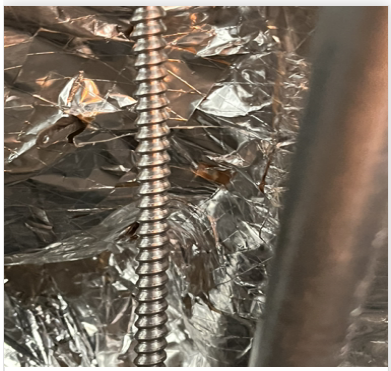
FuseITa6ddb96247ad46.jpeg

Issue Name : No dampers

Description : DOAS-1 some diffusers do not have any balancing dampers.

- **10/06/2022 National TAB - David Annan**
  - Some diffusers do have dampers.

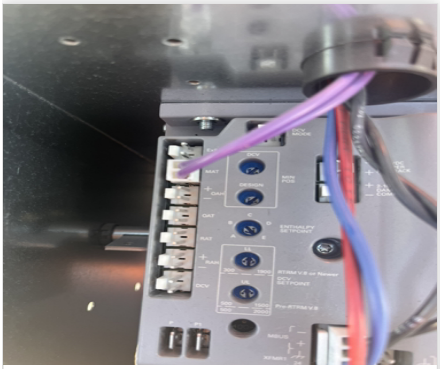
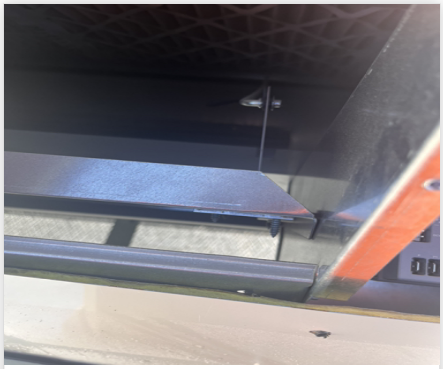
Issue Name : RTU-1 Economizer not functional

Description : Unable to set RTU-1 damper position despite the economizer receiving power. Tried moving damper to closed position the damper did not move.

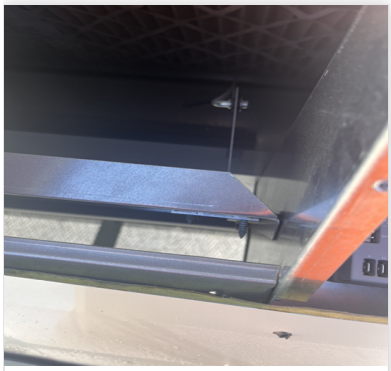
FuseITa54a4243fe7046.jpeg

Issue Name : RTU-1 Low flow

Description : RTU-1 total flow is about 80% of design. Motor sheave is already at 1 turn out (B belt).

- **10/06/2022 National TAB - David Annan**
  - Result of the low flow could be from the return or OA dampers not opening up to provide more airflow.

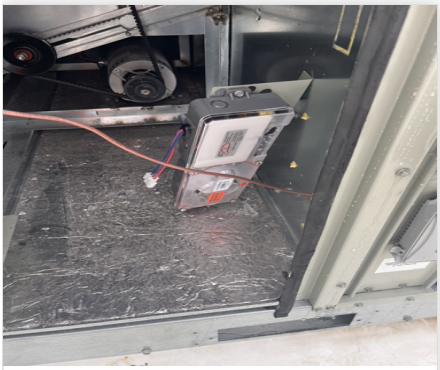
FuseIT06c857d459184d....

Issue Name : RTU-1 Smoke detector not installed-W.I.P

Description : RTU-1 smoke detector is not installed.
