Report: Final Report
Function: Test, Adjust, & Balance
Date: 8/24/2022

08-15 CULVERS - WHEATON, IL

Project: 08-15 CULVERS - WHEATON, IL

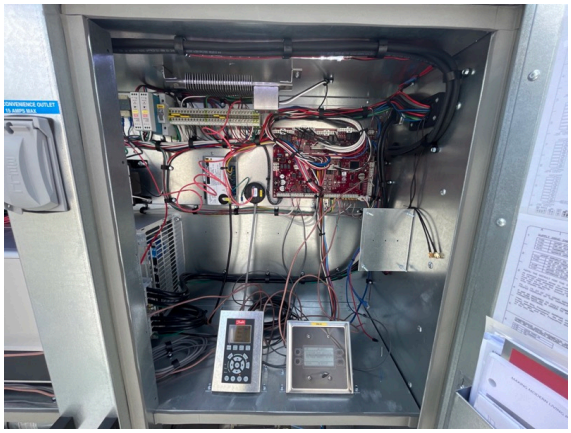
RTU-1
Dining

RTU-1
Control wiring

RTU-1
OA Damper Position Marked

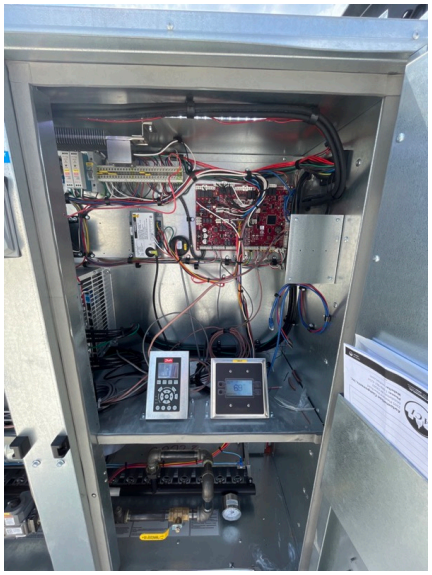
RTU-2
Kitchen

RTU-2
Control wiring

RTU-2
OA damper position

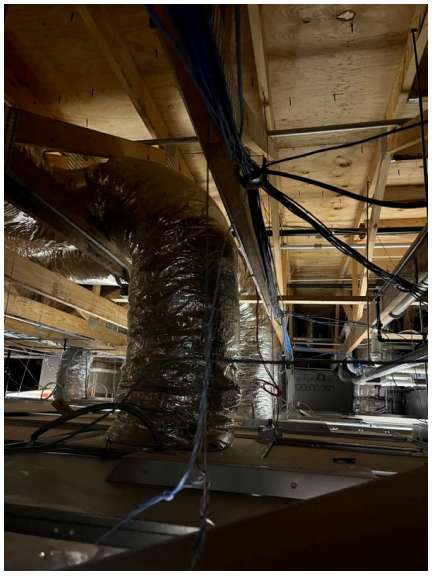
RTU-2
Cookline diffuser drops.

RTU-2
Cookline diffusers perforated.

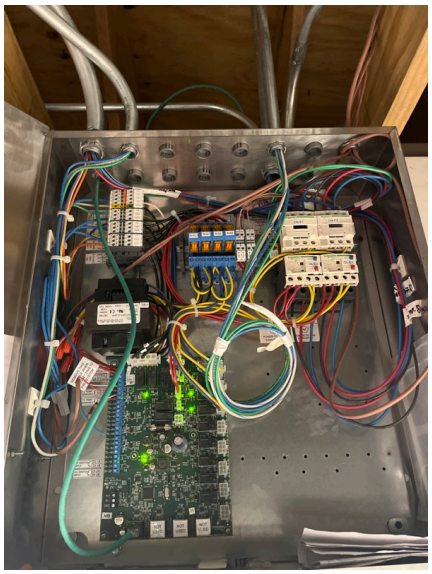
Accurex Hood Control

Accurex Box

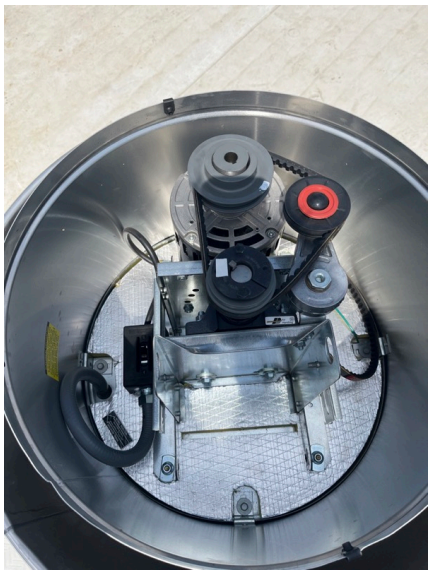
PRV-2
HD-1 Griddle

PRV-2
Disconnect installed.

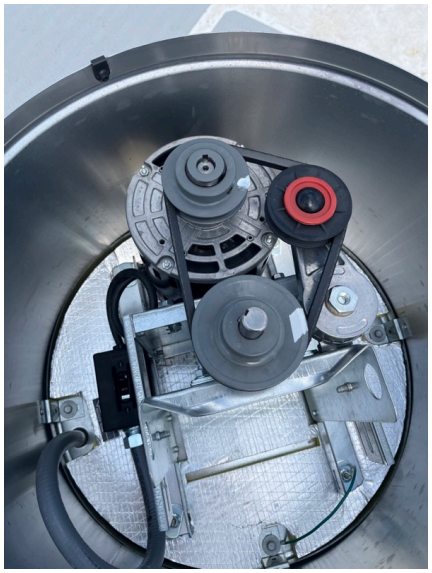
PRV-3
HD-2 Fryer

PRV-3
Disconnect installed.
