Report: TAB Report

Function: Test, Adjust, & Balance

Date: 12/04/2025

11-24-25 WAWA #7207 CINCINNATI, OH

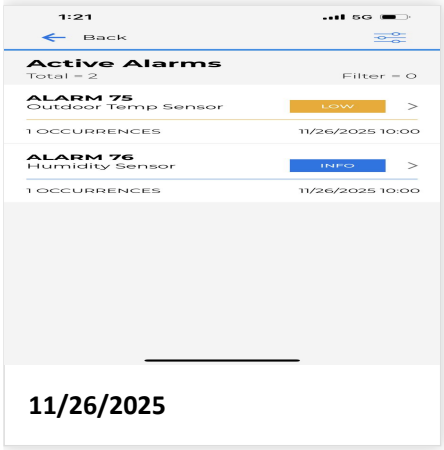
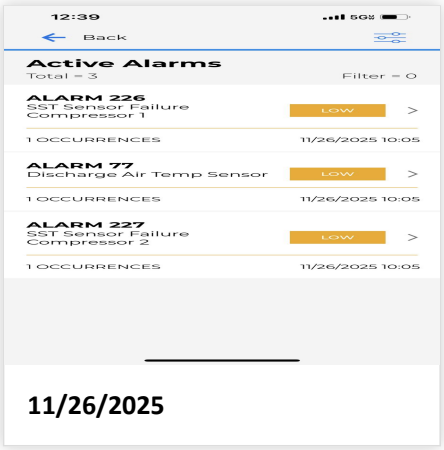
Issue Name : RTU ALARMS

Description : Alarms present on RTUs. Rtu 1: Alarm 75, Alarm 76 Rtu 2: Alarm 77, Alarm 226, Alarm 227
