**Report: TAB Report**

**Function: Test, Adjust, & Balance**

## 10-20-25 QT #0783 MCDONOUGH, GA

QUIKTRIP

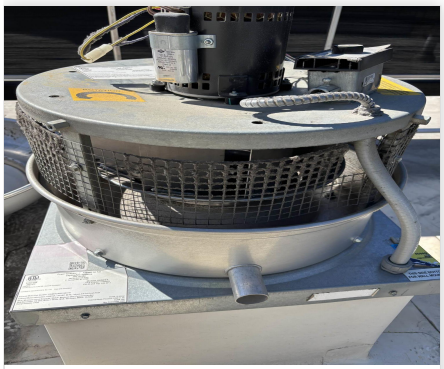
**Issue Name :** EF 1 - MOTOR IS NOT FUNCTIONING

**Description :** Exhaust Fan 1, restroom and combi oven exhaust fan, motor is not working. Replacement motor request has been put in with QT Facility Support.
