Report: TAB Report

Function: Test, Adjust, & Balance

10-06-25 QT #1720 GAINESVILLE, GA

Project: 10-06-25 QT #1720 GAINESVILLE, GA

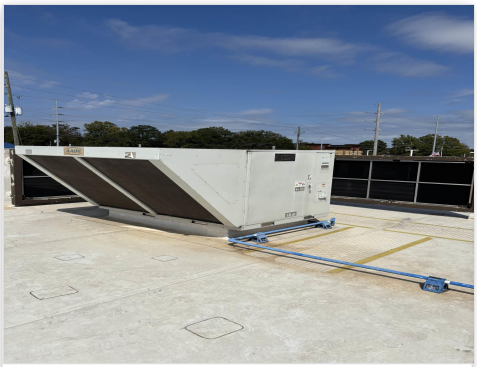
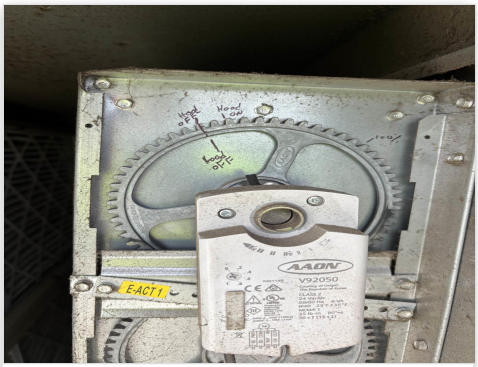
Asset: RT-1 AREA:SALES FLOOR

Notes:
OA HOOD ON AND OFF SETPOINT PICTURE WITH UNIT PICTURE.

HOOD OFF SETPOINT: 26%

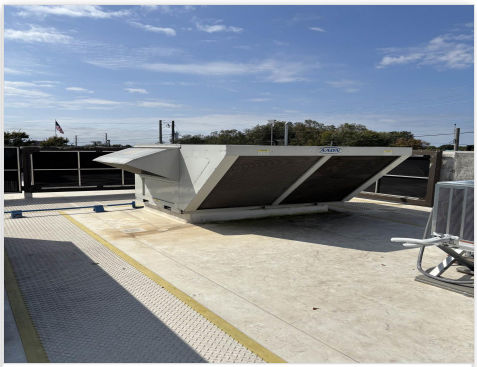
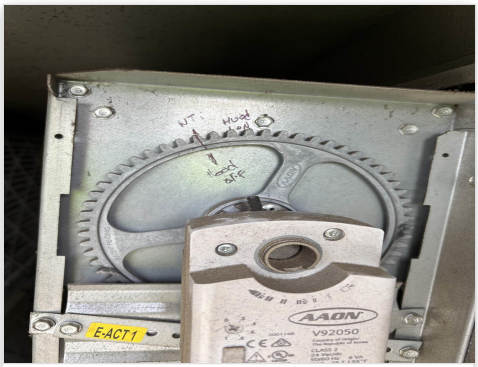
Asset: RT-2 AREA:SALES FLOOR

Notes:
OA HOOD ON AND OFF SETPOINT PICTURE WITH UNIT PICTURE.

HOOD OFF SETPOINT: 26%

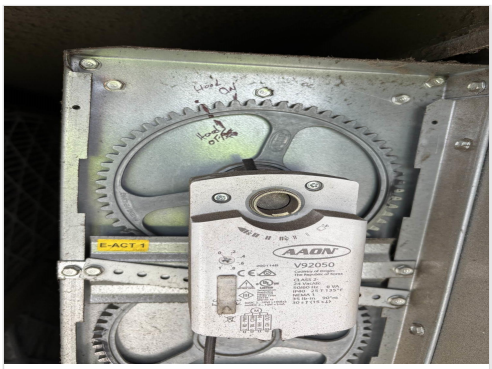
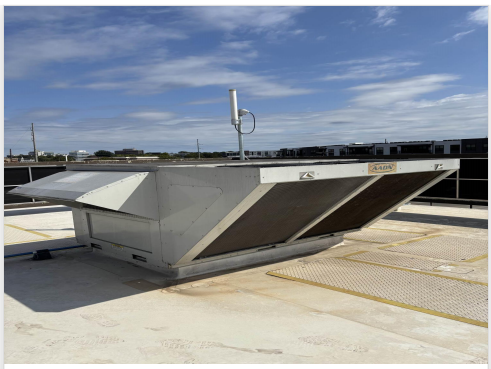
Asset: RT-3 AREA:BOH/KITCHEN

Notes:
OA HOOD ON AND OFF SETPOINT PICTURE WITH UNIT PICTURE.

HOOD OFF SETPOINT: 26%

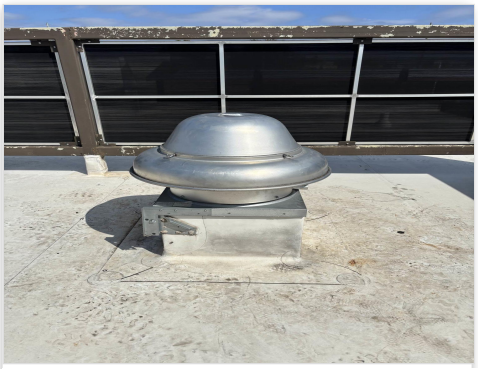
Asset: EF1 AREA:RR/JANITOR

Notes:
[1] UNABLE TO READ VOLTS AND AMPS SAFELY

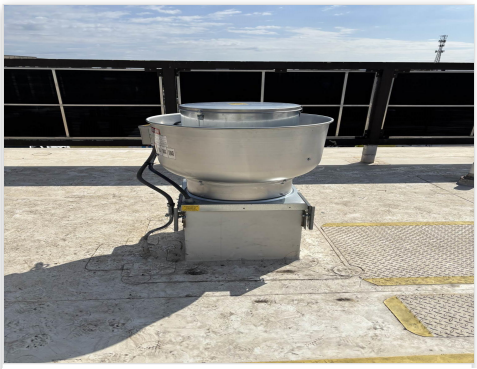
Asset: EF3 AREA:KITCHEN HD

Notes:
UNABLE TO BALANCE HOOD THROUGH EMERSON, BALANCED AT HOOD CONTROL PANEL
