Report: ISSUES

Function: Test, Adjust, & Balance

Date: 09/23/2025

Forge HQ (Kansas City, MO)

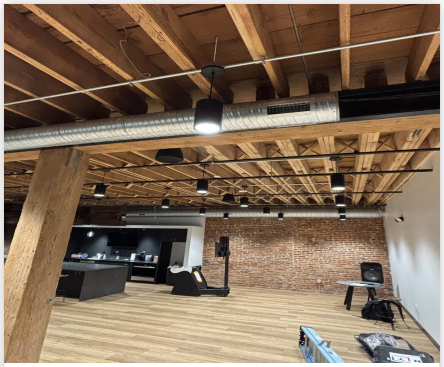
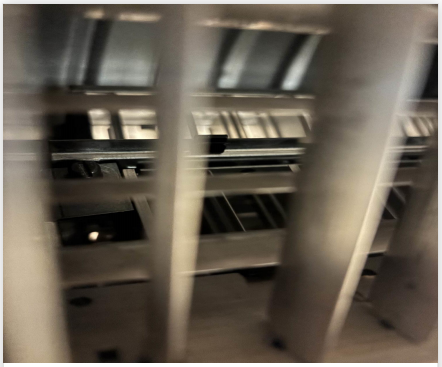
Issue Name : FCU2: Loose/Disconnected Face Damper

Description : The face damper for the grille was loose. The damper came off the grille and fell into the duct when attempting to balance. Needs to be reconnected.

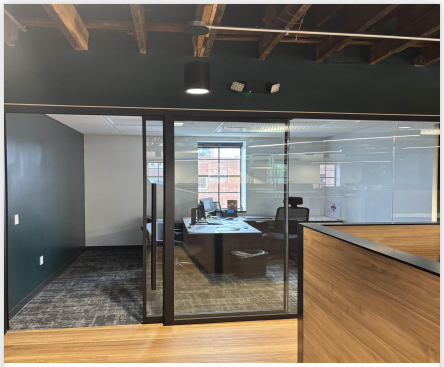
Issue Name : RTU-4: Broken Damper Handle

Description : The damper handle is broken. There is no way to adjust the damper position/airflow. New damper needed.
