Report: TAB REPORT

Function: Test, Adjust, & Balance

Date: 07/19/2024

07-15-24 CAVA RIVER FOREST, IL

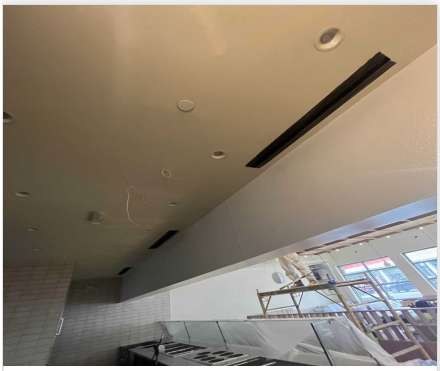
Issue Name : Cookline Diffusers

Description : Unable to balance cookline/linear diffusers around serving/cooking area due to hard ceiling and no access to the dampers located above the linear diffusers.

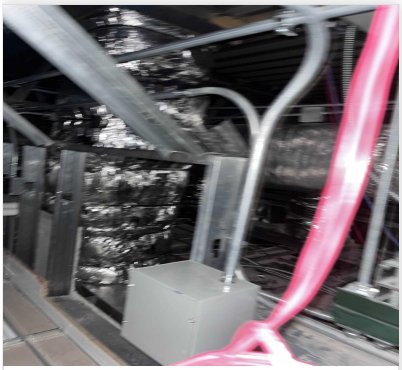
Comment:

Wrapped
