Report: TAB Report

Function: Test, Adjust, & Balance

10-27-25 QT #1180 COLUMBIA, SC

QUIKTRIP

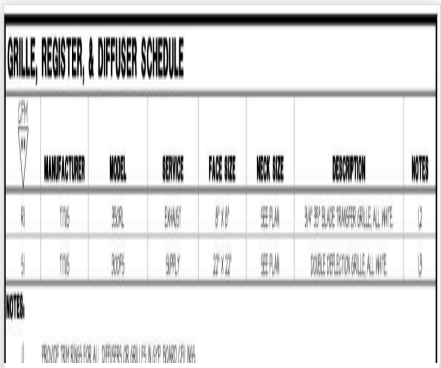
Issue Name : Incorrect Kitchen Diffusers

Description : The kitchen diffusers 3-1 through 3-4 are not the correct type. They should be the Titus S1 diffuser. The contractor is aware and they will be replaced in the near future. Pictured on the right is the correct style diffuser.

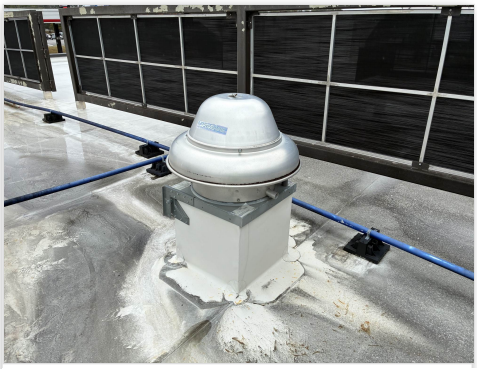
Asset: EF1 AREA:RR/JANITOR

Notes:
[1] NO DAMPER FOUND ON COMBI-OVEN EXHAUST GRILLE OR ON OTHER EF INTLET TO PULL MORE AIR FROM COMBI-OVEN GRILLE. DAMPERS MAY BE INSTALLLED BUT ARE INACCESSIBLE IF SO.
