Report: TAB Report
Function: Test, Adjust, & Balance
Date: 09/23/2025
Completed By: National TAB

06-09-25 WAWA #6305 WAYCROSS, GA

Project: 06-09-25 WAWA #6305 WAYCROSS, GA

Table Of Contents

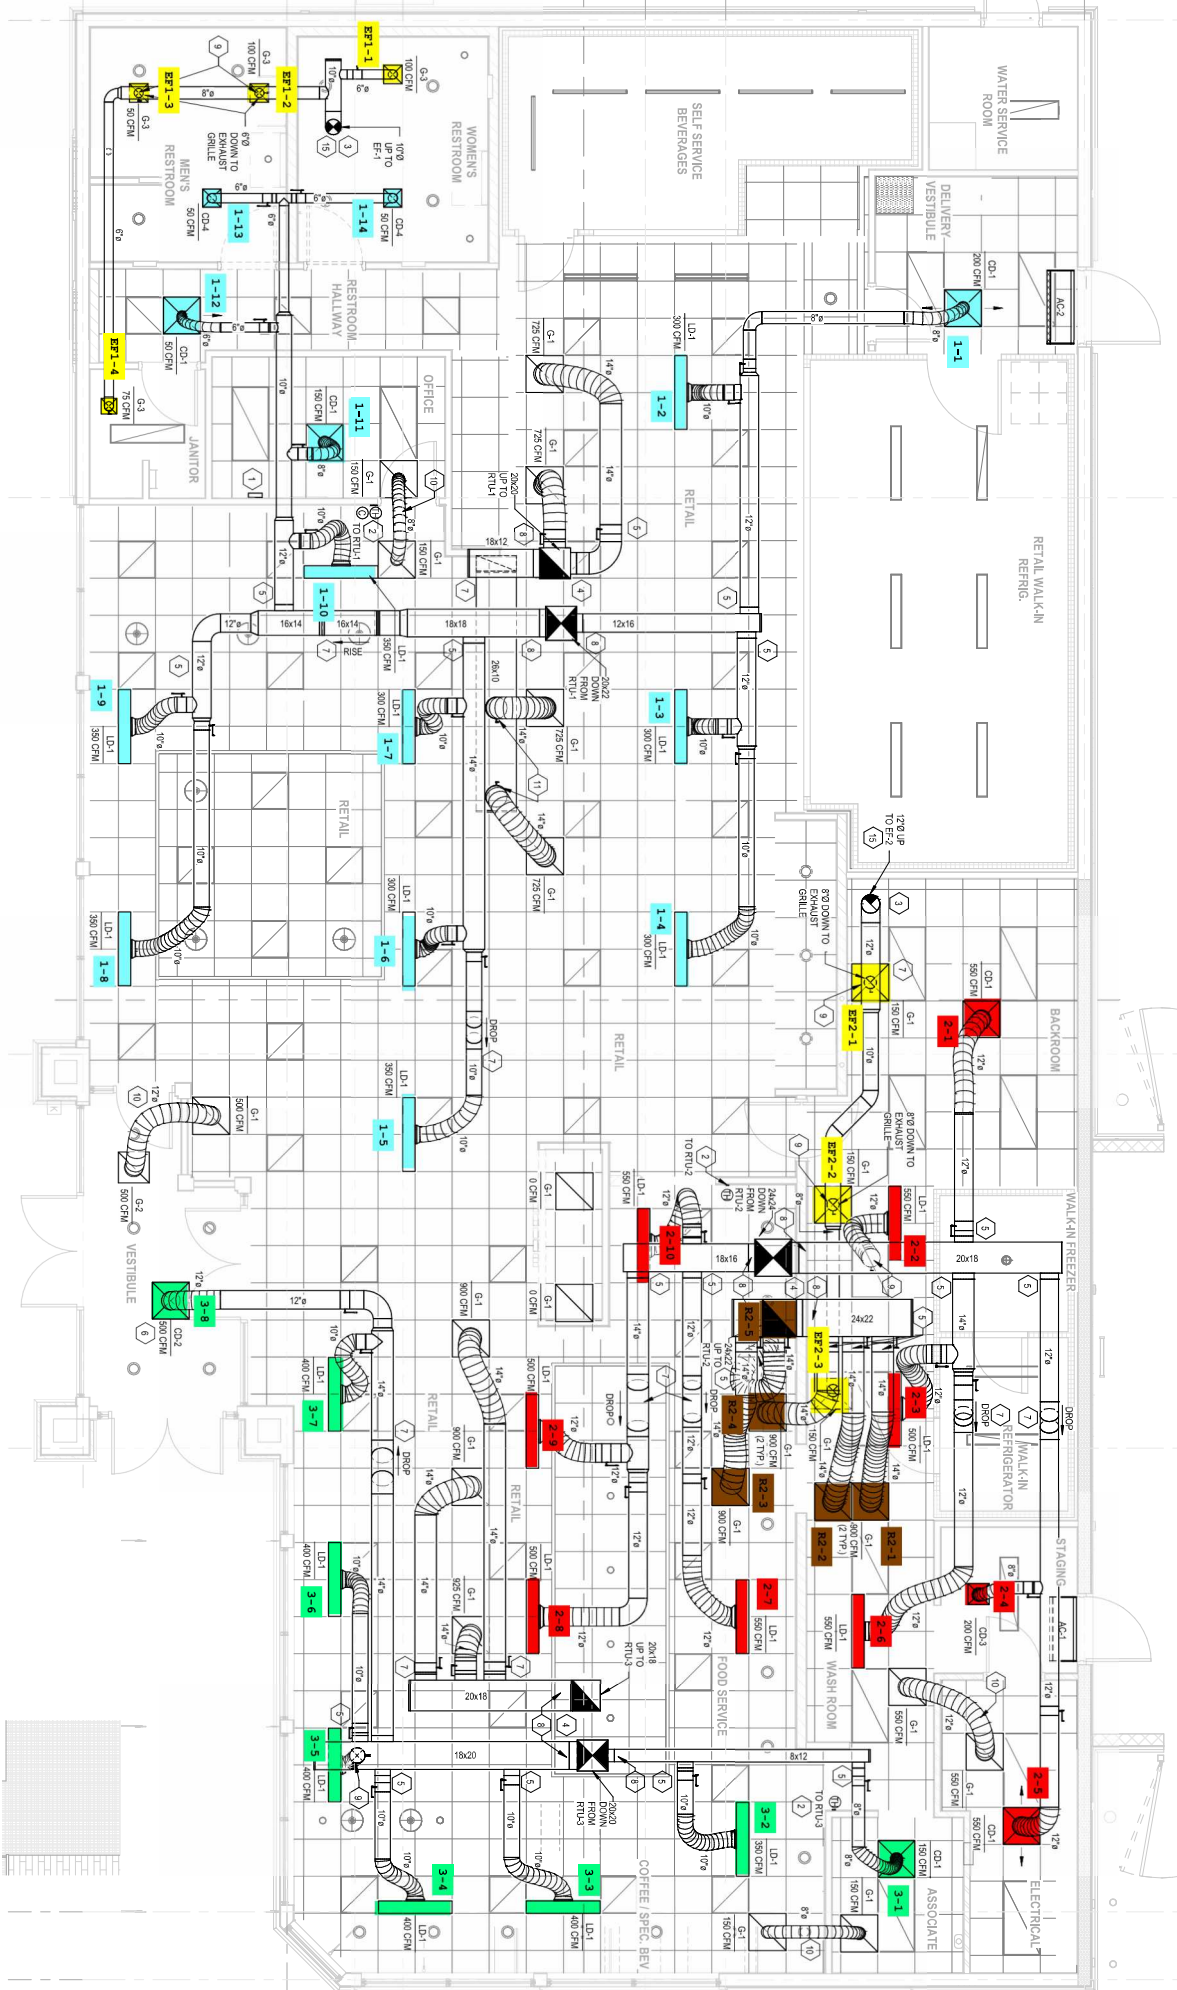
Asset	Notes	Date	Written By
EGRD3	No damper installed. However diffusers were balanced within design without the damper being installed. OK as-is.	09/23/2025	Stephen Tassinaro
