Report: TAB REPORT
Function: Test, Adjust, & Balance
Date: 02/05/2024

01-22-24 KRISPY KREME METARRAIRE, LA

Krispy Kreme

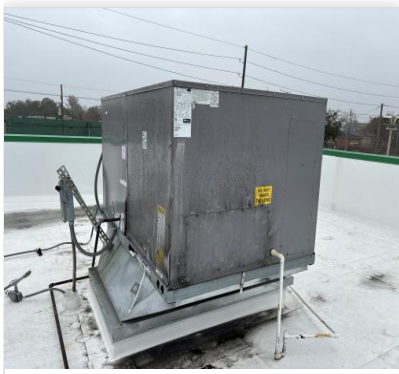
Issue Name : 01: RTU-1 Not operational
Description : The unit was turned off at the disconnect to obtain data from inside the motor compartment. After gathering data, unit was turned back on again and the unit operated for a couple seconds before coming to a complete stop. It was observed that the unit was rotating Clockwise and Rotation should be Counterclockwise. Unit does not turn on anymore. Further investigation is required.

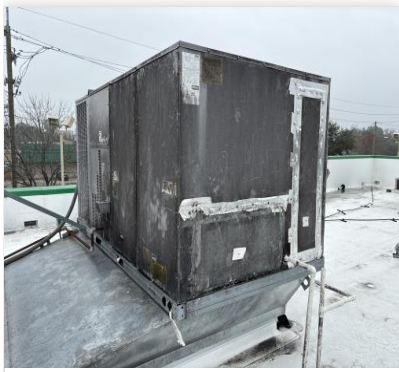
Issue Name : 12: RTU-2 Dirty OA Filters
Description : Filters are dirty and slightly damaged. Recommend to cleaning and may want to replace soon.
Created By : National TAB **Assigned To :** National TAB - Antonio Flores-De La Cruz
Status : Open
Priority : Low **Asset Tag :**
Originated Date : 01/25/2024 - Antonio Flores-De La Cruz - National TAB

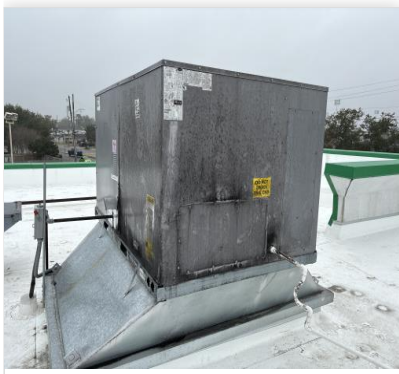
Issue Name : 10: RTU-3 Growth inside Motor Compartment
Description : Microbial growth is on the walls and the panel of the motor compartment. Recommend cleaning
Created By : National TAB **Assigned To :** National TAB - Antonio Flores-De La Cruz
Status : Open
Priority : Medium **Asset Tag :**
Originated Date : 01/25/2024 - Antonio Flores-De La Cruz - National TAB

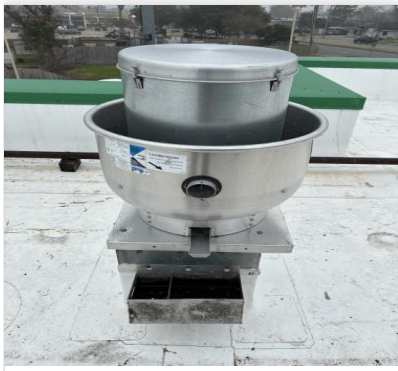
Issue Name : 04: EF-2 (Dough Proofer) high on flow
Description : The proofer hood airflow is pretty high for the application as well. It's operating around 850 CFM but we think it should be closer to 450 CFM. We can't slow down because the belt is too loose, so a smaller belt is recommended.

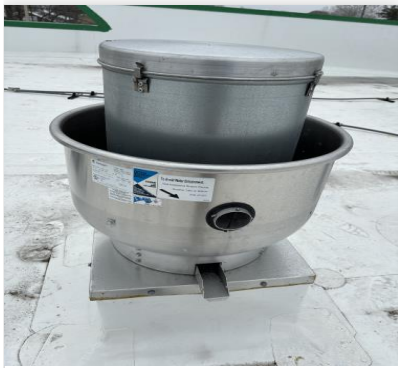
Issue Name : 03: EF-3 (Dish hood) high on flow/runs constantly
Description : There is an exhaust fan that pulls from above the dish washer. It is really high on flow (1600 CFM). That seems really excessive for this application. It would likely be a good idea to replace this with a smaller direct drive fan at a much lower exhaust rate.
Created By : National TAB **Assigned To :** National TAB - Will Turnbough
Status : Open
Priority : High **Asset Tag :** EF3
Originated Date : 02/23/2024 - Will Turnbough - National TAB

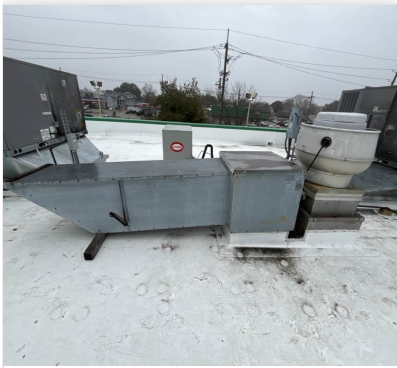
MAU-1

Issue Name : 10: MUA-1 Belt is too long
Description : While trying to set the pulley to minimum, the belt is too long to properly reduce speed and apply tension to the belt. Recommend obtaining a smaller belt and setting it to minimum on the sheave.
Created By : National TAB **Assigned To :** National TAB - Antonio Flores-De La Cruz
Status : Open
Priority : High **Asset Tag :**
Originated Date : 01/25/2024 - Antonio Flores-De La Cruz - National TAB
