Report: RENEW

Function: Test, Adjust, & Balance

Date: 11/17/2022

**11-14 FREDDY'S - BRIDGETON, MO - RENEW
3H (5)**

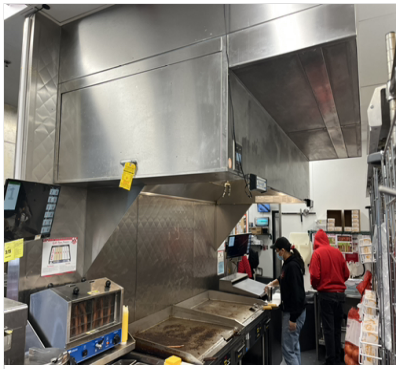
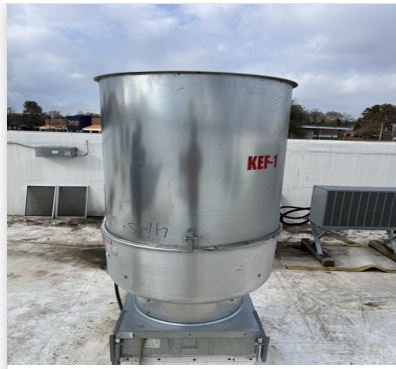
OA CFM	882
OA DAMPER POSITION	27%
FAN SUCTION AND DISHCHARGE PRESSURE	-0.10" MA 0.58" DISCHARGE
BLOWER MOTOR RLA / FLA	10.4/10.4/10.4
RTU3 (TAKE PICTURE OF UNIT)	
MFG & MODEL NUMBER	NA
OA CFM	NA
OA DAMPER POSITION	NA
FAN SUCTION AND DISHCHARGE PRESSURE	NA
BLOWER MOTOR RLA / FLA	NA
KEF1 - HOOD 1 (TAKE PICTURE OF UNIT)	
MFG & MODEL NUMBER	CAPTIVE AIRE / DU85HFA

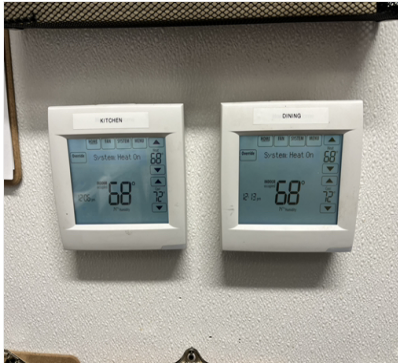
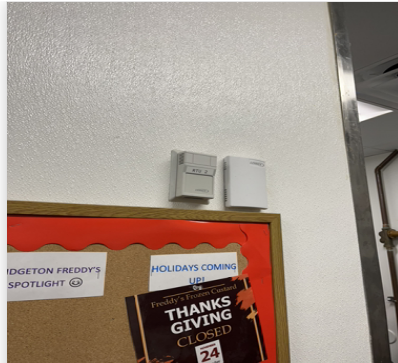
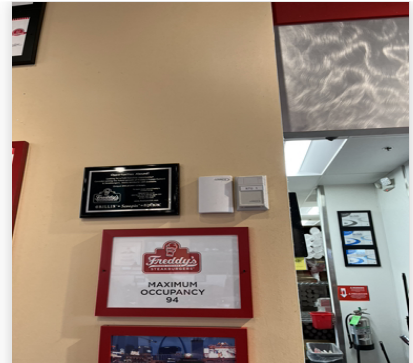
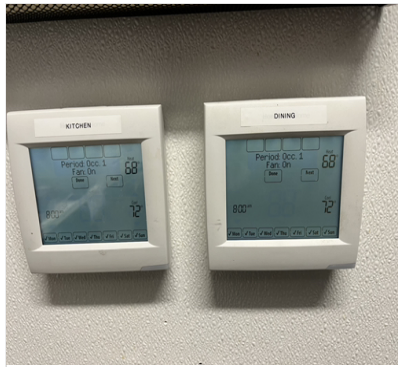
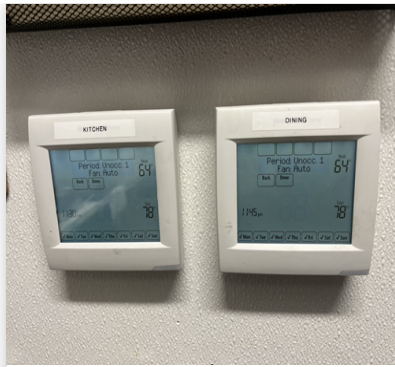
TAKE PICTURE OF THERMOSTATS AND WALL SENSORS

ARE THERMOSTATS PROGRAMMED FOR OCCUPIED HOURS AND IS THE FAN IN "ON" MODE DURING OCCUPIED TIMES

YES

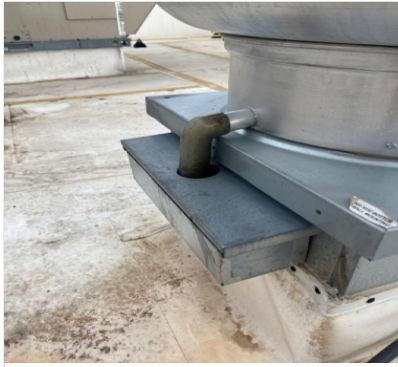
EXHAUST FAN KEF1 GREASE CUP PROPERLY INSTALLED

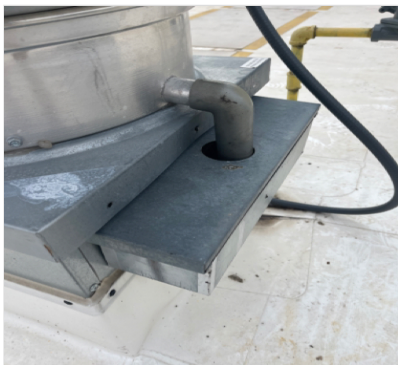
EXHAUST FAN KEF2 GREASE CUP PROPERLY INSTALLED
