Report: TAB REPORT
Function: Test, Adjust, & Balance
Date: 06/27/2024

PROJECT
06-24-24 DOMINICKS SCOTTSDALE, AZ

Project: 06-24-24 DOMINICKS SCOTTSDALE, AZ

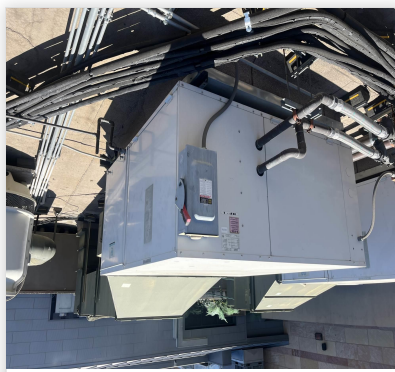
WSHP-1

Dining room diffusers feed wall plenum-see issue.
WSHP-2	BAR	20	334	Located on Roof, coil / blower wheel in need of cleaning. Manual OA inlet fully closed.
WSHP-3	2 nd Floor Private Dining	3	458	Located in neighboring tenant space. Return pulls from ceiling plenum in that space.
WSHP-4	Front kitchen	5	365	Return Filter found clogged initially. Not Listed on original plans.
WSHP-5	Wine Room	3	480	Very limited access, unclear on exact duct routing as wine chillers are also mounted above this space. Possibly Served by second WSHP. Controls company listed Small and Large Wine units, only one appeared ducted to diffusers in space.
WSHP-6	South Dining	3	407	Not listed on original plans.
WSHP-7	Private Dining	3	266	
WSHP-8	Lobby / RR	5	320	
WSHP-9	Rear Kitchen	5	339	Missing Electrical Panel Cover / Unit Label
WSHP-10	South Dining Host Wall	?	831 total cfm	Unable to access unit to determine model / tonnage. Not listed on original Plans.

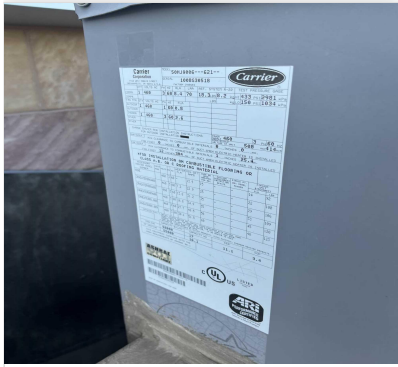
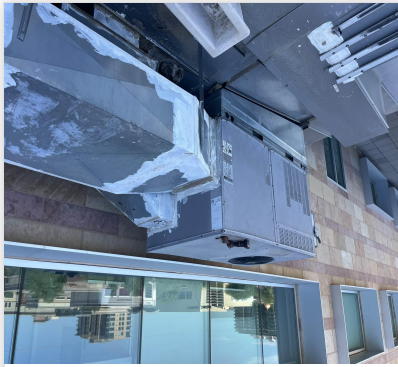
RTU-1	Stairwell	3	385	Return Filters found dirty, removed for testing. Recommend replacement.
RTU-2	Pool South	5	462	Cooling not operational at time of Visit. Service company called. Discharges through 3 grilles, air not distributed.
RTU-3	Pool North	5	454	Discharges through 3 grilles, air not distributed.

Issue Name : RTU-3: Pool RTU Fan Pulley Cracked
Description : Plastic fan pulleys installed on Pool RTUs appear damaged. RTU-3 pulley has significant crack developing. Recommend replacement.
Created By : National TAB **Assigned To :** National TAB - Michael McDonnell
Status : Open
Priority : High **Asset Tag :**
Originated Date : 07/26/2024 - Michael McDonnell - National TAB
