Report: TAB REPORT
Function: Test, Adjust, & Balance
Date: 06/27/2024

PROJECT
06-24-24 DOMINICKS SCOTTSDALE, AZ

Prime Steak Concepts

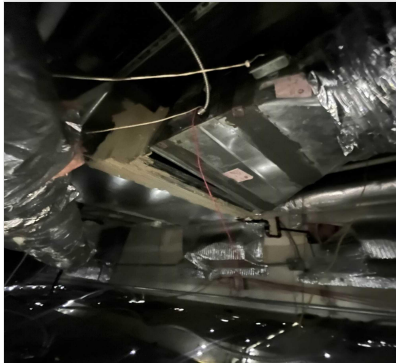
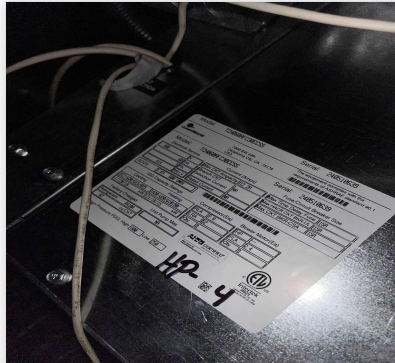
Issue Name : WSHP-4: Kitchen- Return Filter found Clogged
Description : Return filter installed in WSHP-4 was found extremely dirty and clogged. When filter was replaced, airflow increased from 1100cfm to 1823. Recommend filter on this system is changed more frequently due to location (kitchen) to maintain consistent cfm from WSHP.
Created By : National TAB **Assigned To :** National TAB - Michael McDonnell
Status : Open
Priority : InfoOnly **Asset Tag :**
Originated Date : 07/26/2024 - Michael McDonnell - National TAB

- [1] SERVES FRONT KITCHEN AREA-4 DIFFUSERS IN COOKING AREA AND HAS 2 GRILLES DUCTED FROM UNIT TO 2ND FLOOR OFFICE. OFFICE GRILLES TOTAL 401 CFM. THERE IS NO RETURN IN OFFICE.
- [2] FILTER INSTALLED ON RETURN INITIALLY FOUND CLOGGED, REPLACED FILTER. AIRFLOW INCREASED FROM 1100 CFM TO 1823 CFM.
- [3] NOT DUCTED FOR OA.

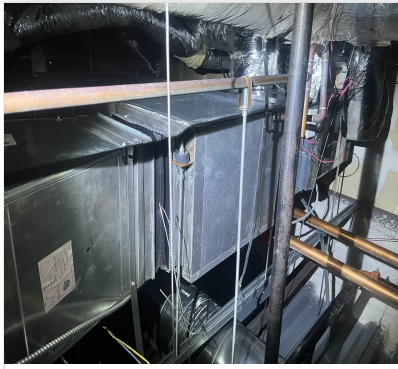
WSHP-9

Issue Name : WSHP-9: Electrical Compartment Cover Missing
Description : Unit cover for the electrical/control compartment is missing. Could not be located, recommend it's installed.
Created By : National TAB **Assigned To :** National TAB - Michael McDonnell
Status : Open
Priority : Low **Asset Tag :**
Originated Date : 07/26/2024 - Michael McDonnell - National TAB

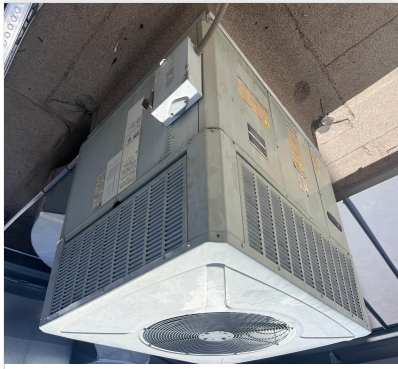
Issue Name : RTU-1: Power Conduit Damaged
Description : Power conduit running from the roof to RTU-1 is damaged and wiring is exposed to the elements. Recommend conduit is repaired.
Created By : National TAB **Assigned To :** National TAB - Michael McDonnell
Status : Open
Priority : Medium **Asset Tag :**
Originated Date : 07/25/2024 - Michael McDonnell - National TAB

- [1] SERVES DIFFUSERS IN STAIRWELL. FILTER INSTALLED AT RETURN, FOUND DIRTY. REMOVED FOR TESTING. UNIT OPERATES IN FAN AUTO.
- [2] POWER CONDUIT TO UNIT DAMAGED-SEE ISSUE
- [3] NO FILTER INSTALLED AT COIL.

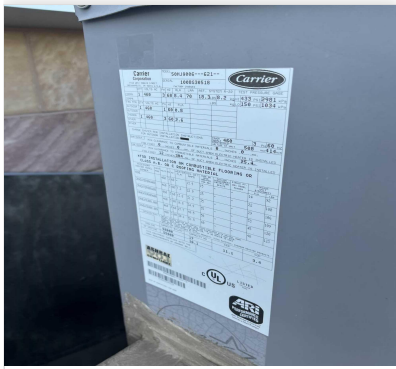
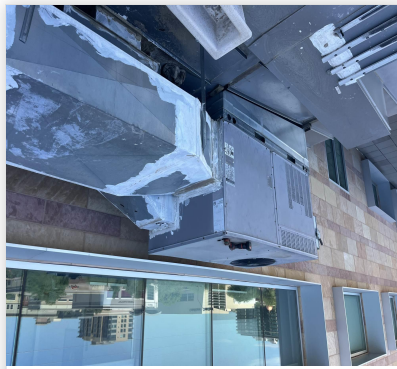
Issue Name : RTU-3: Pool RTU Fan Pulley Cracked
Description : Plastic fan pulleys installed on Pool RTUs appear damaged. RTU-3 pulley has significant crack developing. Recommend replacement.
Created By : National TAB **Assigned To :** National TAB - Michael McDonnell
Status : Open
Priority : High **Asset Tag :**
Originated Date : 07/26/2024 - Michael McDonnell - National TAB

Notes:
 [1] UNIT NOT OPERATING COOLING AT TIME OF VISIT. REPAIR WAS IN PROGRESS.
 [2] FAN PULLEY APPEARS DAMAGED.

[1] FAN PULEY DAMAGED / CRACKED

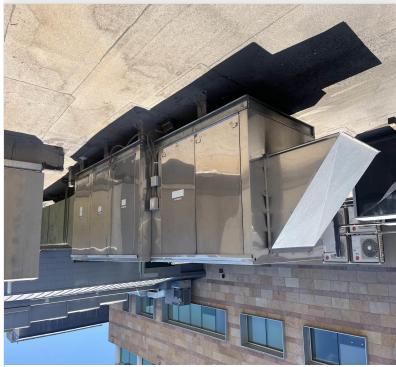
KEF-1 / PCU

Issue Name : KEF-1: Controls - Always Operational
Description : Hood controls in kitchen space do not control KEF-1. Kitchen exhaust hoods appear to run 24/7. This is unnecessarily exhausting treated air from space when cooling is not occurring. Only roof disconnect powers off fan. Recommend controls are inspected/corrected.
Created By : National TAB **Assigned To :** National TAB - Michael McDonnell
Status : Open
Priority : High **Asset Tag :**
Originated Date : 07/25/2024 - Michael McDonnell - National TAB

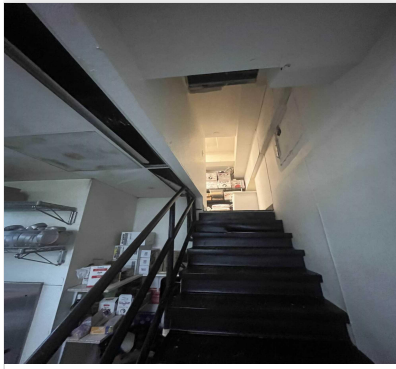
OFFICE

Issue Name : Office Comfort: Portable AC Unit
Description : Managers office running portable AC unit due to hot conditions in the office. Portable AC unit is exhausting hot air into kitchen space below.
Created By : National TAB **Assigned To :** National TAB - Michael McDonnell
Status : Open
Priority : InfoOnly **Asset Tag :**
Originated Date : 07/26/2024 - Michael McDonnell - National TAB
