**Report: TAB REPORT**  
**Function: Test, Adjust, & Balance**  
**Date: 06/27/2024**

**PROJECT**  
**06-24-24 DOMINICKS SCOTTSDALE, AZ**

15169 N Scottsdale Rd

Prime Steak Concepts

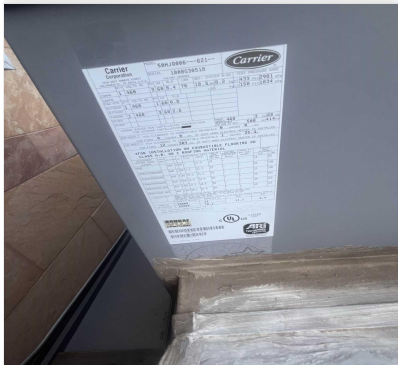
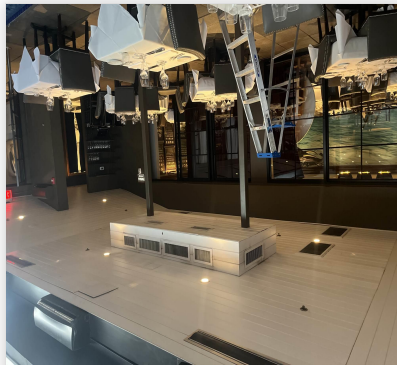
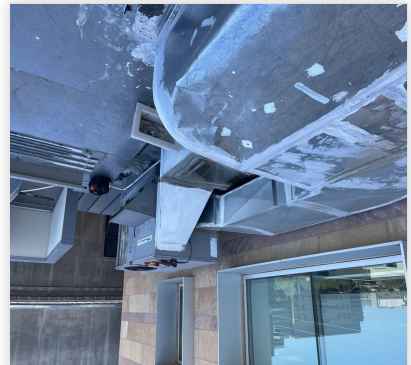
RTU-1	Stairwell	3	385	Return Filters found dirty, removed for testing. Recommend replacement.
RTU-2	Pool South	5	462	Cooling not operational at time of Visit. Service company called. Discharges through 3 grilles, air not distributed.
RTU-3	Pool North	5	454	Discharges through 3 grilles, air not distributed.

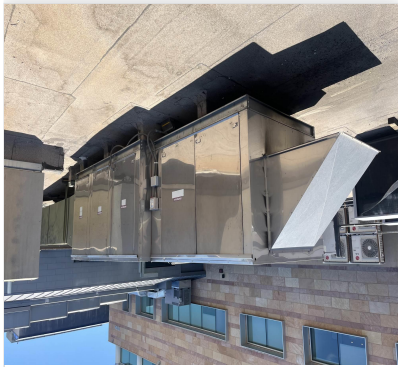
KEF-1 / PCU

2. Kitchen Exhaust Hoods (HD-1 and HD-2) are not controlled by Hood Switch. Respective fans (KEF-1 and MAU) appear to run 24/7, only controlled by roof disconnect.

**Issue Name :** KEF-1: Controls - Always Operational  
**Description :** Hood controls in kitchen space do not control KEF-1. Kitchen exhaust hoods appear to run 24/7. This is unnecessarily exhausting treated air from space when cooling is not occurring. Only roof disconnect powers off fan. Recommend controls are inspected/corrected.  
**Created By :** National TAB                      **Assigned To :** National TAB - Michael McDonnell  
**Status :** Open  
**Priority :** Medium                                      **Asset Tag :**  
**Originated Date :** 07/25/2024 - Michael McDonnell - National TAB

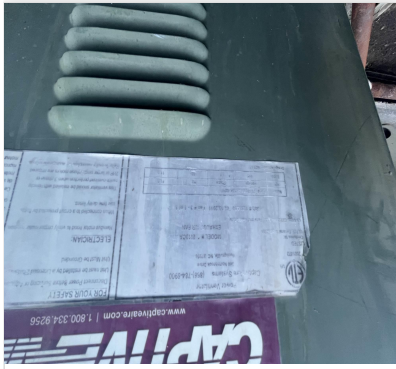
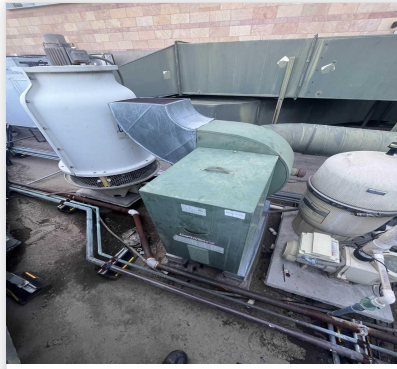
**Issue Name :** KEF-2 Dish Exhaust: Controls - Not Operational  
**Description :** HD-3, Dishwasher hood, is served by KEF-2. Fan is functional but is not operating. Hood Switch does not control fan. Left off at roof, recommend controls installed.

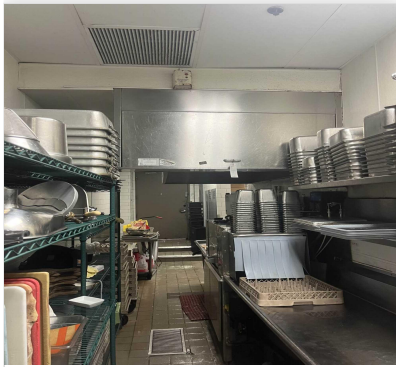
HOOD-3

3. Dishwasher exhaust (HD-3) and its respective fan is not operating. The fan is functional but has no controls in the space below and can only be operated by roof disconnect.

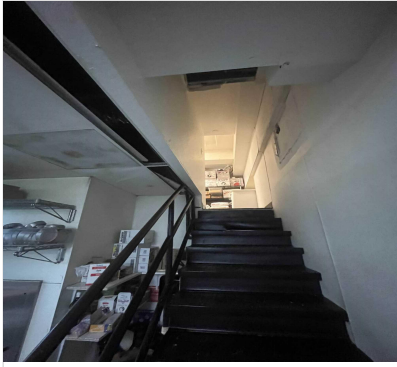
OFFICE

**Issue Name :** Office Comfort: Portable AC Unit  
**Description :** Managers office running portable AC unit due to hot conditions in the office. Portable AC unit is exhausting hot air into kitchen space below.  
**Created By :** National TAB                      **Assigned To :** National TAB - Michael McDonnell  
**Status :** Open  
**Priority :** InfoOnly                              **Asset Tag :**  
**Originated Date :** 07/26/2024 - Michael McDonnell - National TAB
