**Report: TAB REPORT**  
**Function: Test, Adjust, & Balance**  
**Date: 06/27/2024**

**PROJECT**  
**06-24-24 DOMINICKS SCOTTSDALE, AZ**

Project: 06-24-24 DOMINICKS SCOTTSDALE, AZ

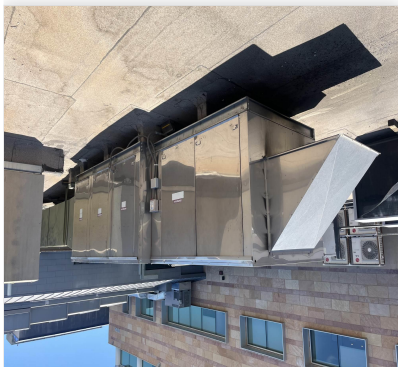
KEF-1 / PCU

**Issue Name :** KEF-1: Controls - Always Operational  
**Description :** Hood controls in kitchen space do not control KEF-1. Kitchen exhaust hoods appear to run 24/7. This is unnecessarily exhausting treated air from space when cooling is not occurring. Only roof disconnect powers off fan. Recommend controls are inspected/corrected.  
**Created By :** National TAB                      **Assigned To :** National TAB - Michael McDonnell  
**Status :** Open  
**Priority :** High                                      **Asset Tag :**  
**Originated Date :** 07/25/2024 - Michael McDonnell - National TAB

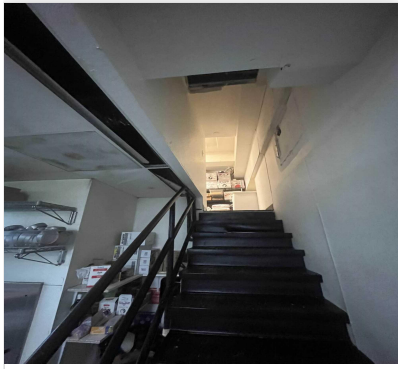
OFFICE

**Issue Name :** Office Comfort: Portable AC Unit  
**Description :** Managers office running portable AC unit due to hot conditions in the office. Portable AC unit is exhausting hot air into kitchen space below.  
**Created By :** National TAB                      **Assigned To :** National TAB - Michael McDonnell  
**Status :** Open  
**Priority :** InfoOnly                                      **Asset Tag :**  
**Originated Date :** 07/26/2024 - Michael McDonnell - National TAB
