Report: TAB REPORT
Function: Test, Adjust, & Balance
Date: 10/31/2023

PROJECT
MISSION HILLS COUNTRY CLUB

10/31/2023 - Summary

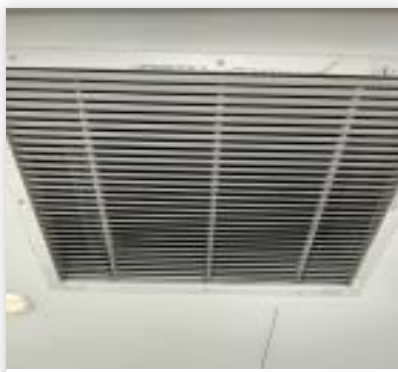
Return
11/01/2023

6. A small return in the workout room is blanked off with cardboard. The larger return is full open. Recommend opening up this blanked off return.

Exhaust has card board 100% blocking airflow, creating noise.
