**National TAB  
1329 E. KEMPER ROAD  
SUITE 4210  
CINCINNATI, OH 45246**

**Report: Final TAB Report  
Function: Test, Adjust, & Balance  
Date: 8/30/2022**

**PROJECT  
08-08 CULVERS - ROGERS, AR**

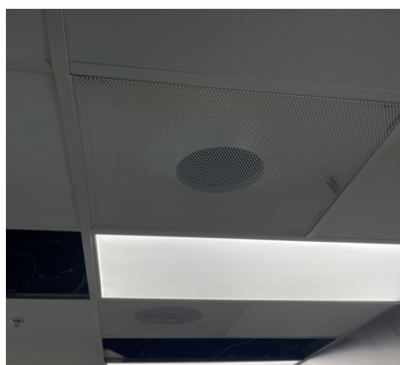
**Diffusers.jpeg**

Perforated diffusers are installed on the cook line? (4-ways will disrupt hood capture)	YES
---	-----

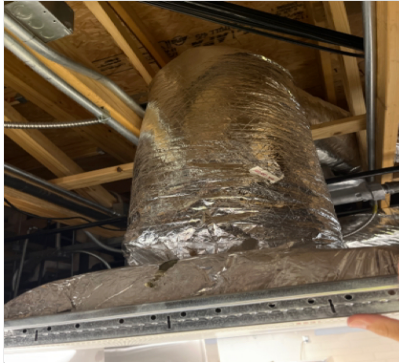
Flexoverstraight.jpeg

On the cookline diffusers neck is there 18" (12" minimum) straight rigid duct run attached?

YES
