**National TAB  
1329 E. KEMPER ROAD  
SUITE 4210  
CINCINNATI, OH 45246**

**Report: Final TAB Report  
Function: Test, Adjust, & Balance  
Date: 8/25/2022**

**PROJECT  
08-08 CULVERS - ROGERS, AR**

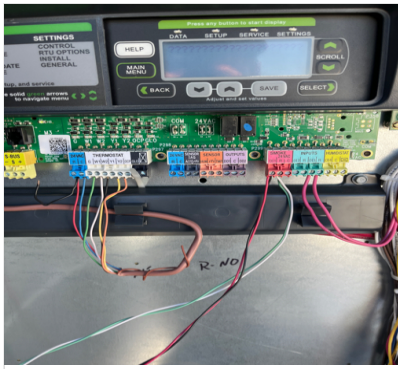
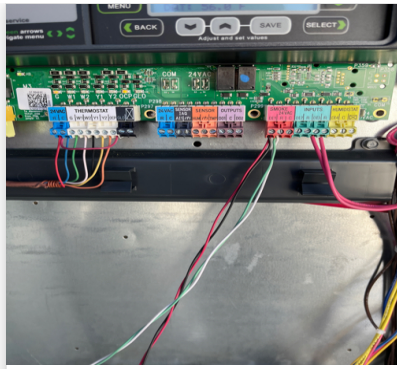
PRODIGY BOARD WIRING

Notes: [1] PRODIGY BOARD IS DEFECTIVE AND NEEDS TO BE REPLACED. UNABLE TO SET ENTHALPY AND OA POSITION. DAMPER POSITION WILL BE MARKED FOR WHEN NEW BOARD COMES IN.

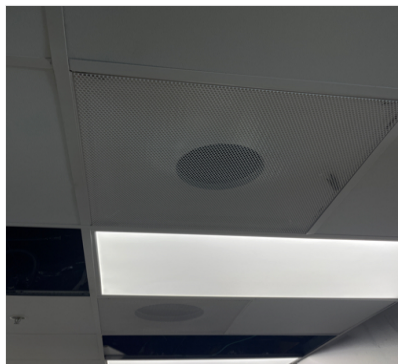
**Diffusers.jpeg**

Perforated diffusers are installed on the cook line? (4-ways will disrupt hood capture)	YES
---	-----

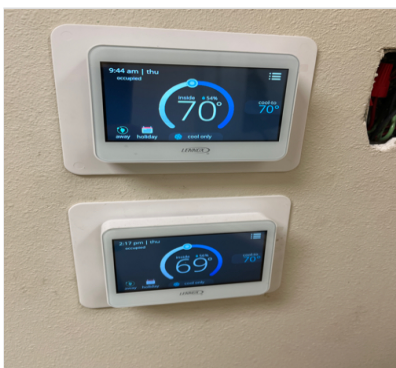
**Thermostats.jpeg**

Thermostats have power?

YES

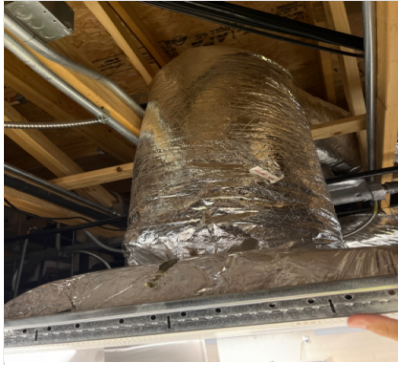
Flexoverstraight.jpeg

On the cookline diffusers neck is there 18" (12" minimum) straight rigid duct run attached?

YES

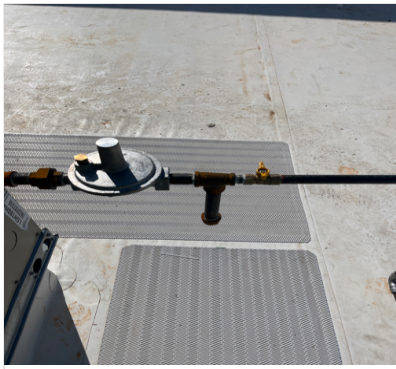
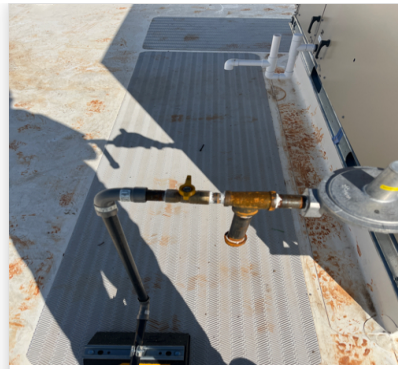
Motors are all operating below the FLA rating?	YES
Are belts tight?	YES
If direct drive unit is the speed controller working.	NA
Is gas piping installed and valves turned on?	INSTALLED. NOT ON

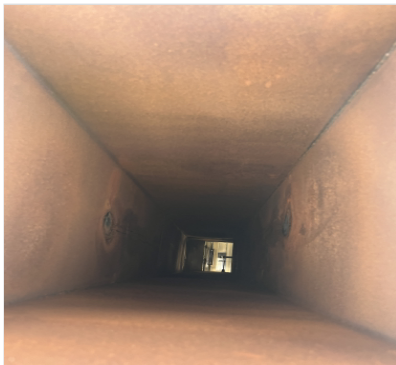
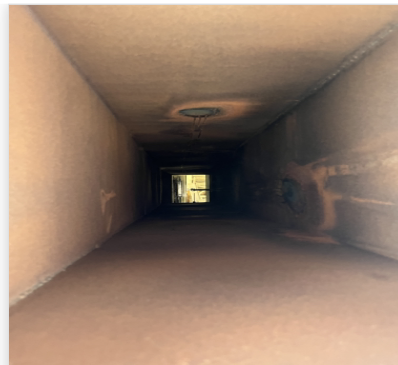
Lean grease rated fans back. Is grease duct installation adequate and is duct ran all the way to the base of the fan?

YES

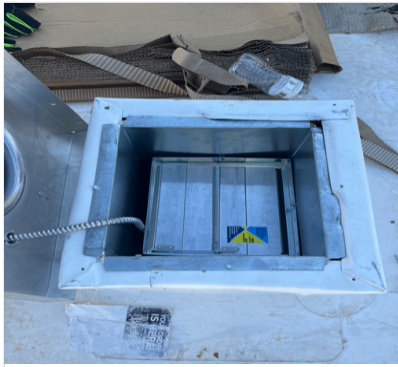
Bddamper.jpeg

For restroom fan(s) is the back draft damper installed and can it fully open?

YES
