PlanGrid Task Report - Feb 14, 2024

L04916_Princeton Woods FSU (Dumfries, VA)

3350 Pine Bluff Drive, Dumfries, Virginia

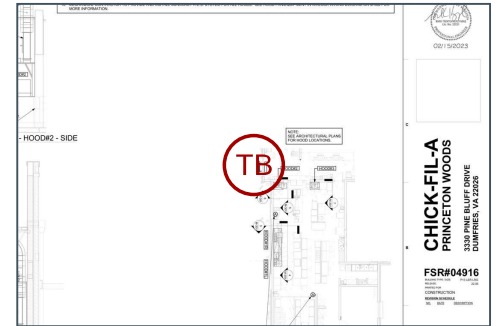
M-301

#123 [CNTL 098] Ansul pull labeling.

Label all Ansul pull stations
for which hoods they serve.

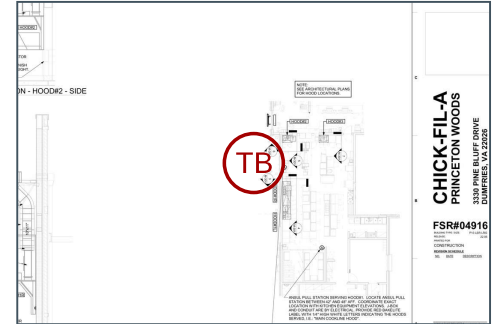
M-301

#122 [CNTL 107] (MISC) Missing Ansul pull stations

Ansul pull stations are not yet installed at locations designated

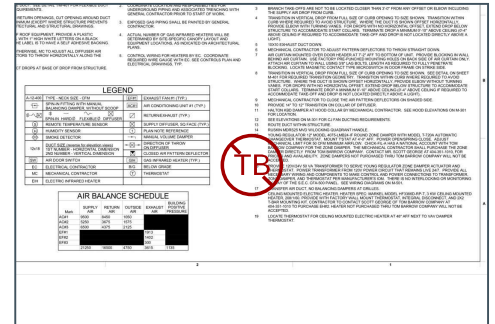
Sheet
M-201

#121 [CNTL 107] (MISC) Zone Damper Thermostats do not have power

Description
Thermostat controlling zone dampers need transformer installed in order to power thermostats

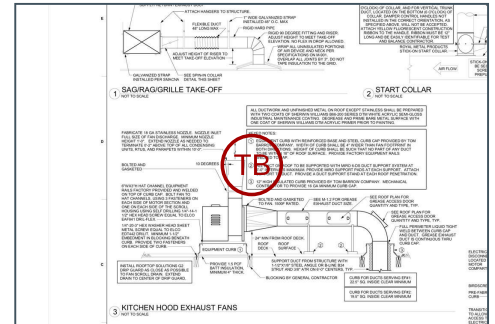
M-401

#120 [EXHA 127] Grease exhaust duct is not supported.

Exhaust duct for EF#1 is to be supported per kitchen hood exhaust fan detail on 6'0" centers.

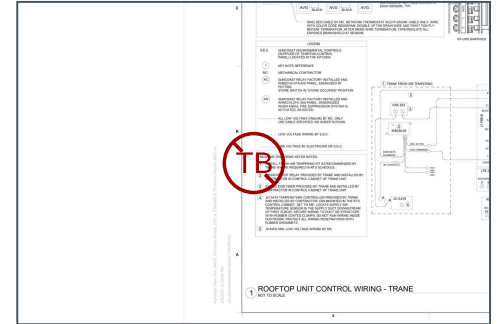
M-501

#119 [UNIT 152] Trane equipment missing field kits.

Trane equipment does not have additional manufacturer supplied, field installed relays, delay timer, or discharge temperature controller with FAT scheduled in design.

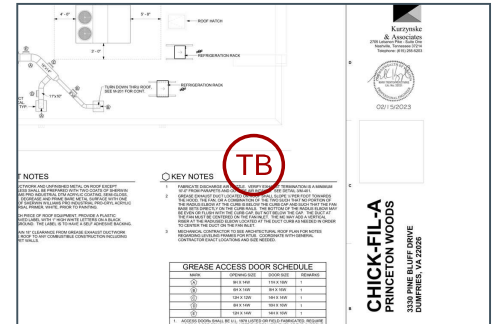
M-250

#118 [UNIT 168] Equipment not secured properly.

Equipment not secured properly to curb, high wind/ seismic clips not installed. Mechanical stated that unit package did not come with seismic clips.
