**Report: TAB Report**  
**Function: Test, Adjust, & Balance**  
**Date: 03/30/2026**  
**Completed By: National TAB**

**PROJECT**  
**01-25-26 QT #1182 COLUMBIA, SC**

580 JAMIL RD

QUIKTRIP  
4705 SOUTH 129TH EAST AVENUE  
TULSA, OK 74134

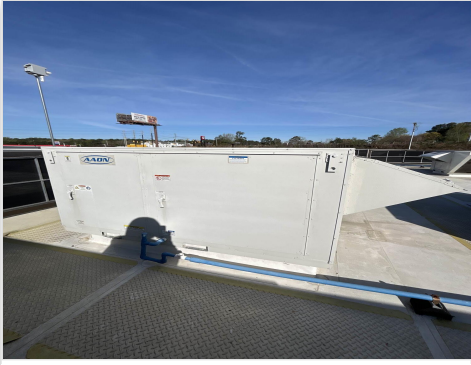
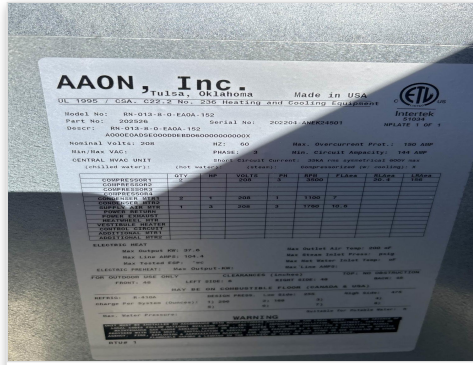
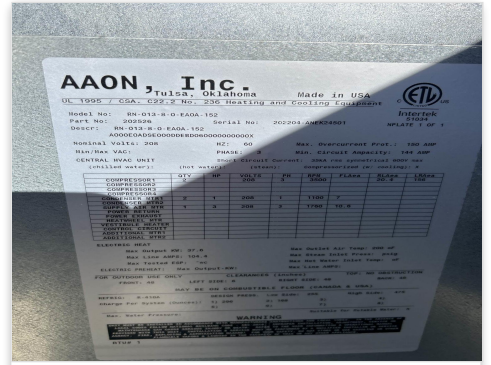
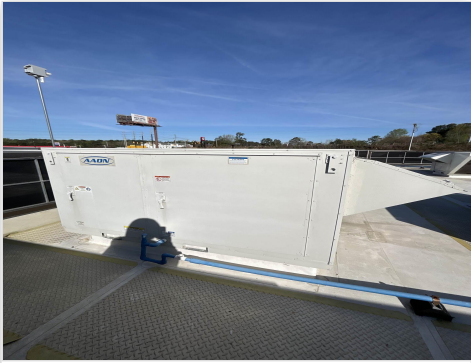
Test Data		
	Design	Actual
SF CFM	4200	4195
SF RPM	-	DD/ 43.8 HZ
OA CFM (Hoods On)	800	836
OA CFM (Hoods Off)	350	358
RL Voltage	-	144.4 VFD
RL Amperage	-	7.4 VFD
VFD Max SetPt	-	43.8 HZ
OA Damper Position (Hoods On)	-	46%
OA Damper Position (Hoods Off)	-	(1)

Notes:  
SEE ISSUES

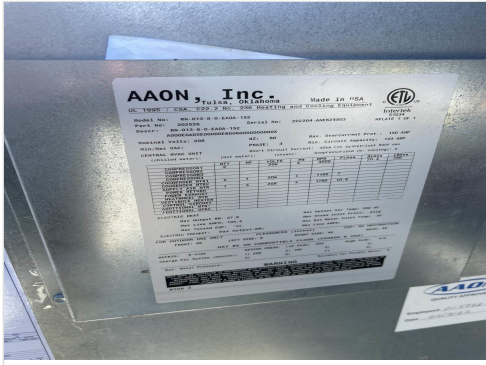
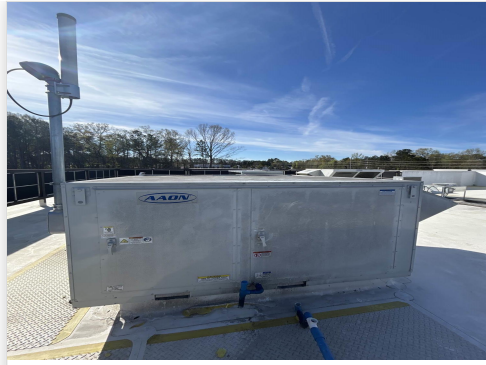
Test Data		
	Design	Actual
SF CFM	4200	3934
SF RPM	-	DD/ 54 HZ
OA CFM (Hoods On)	800	829
OA CFM (Hoods Off)	350	372
RL Voltage	-	184 VFD
RL Amperage	-	8.2 VFD
VFD Max SetPt	-	54 HZ
OA Damper Position (Hoods On)	-	46%
OA Damper Position (Hoods Off)	-	(1)

Performance Data		
	Design	Actual
MA Plenum SP	-	-0.65"
Fan Suction SP	-	-0.91"
Fan Discharge SP	-	1.99"
Total ESP	-	2.64"
Fan Total SP	-	2.90"
