Report: TAB REPORT
Function: Test, Adjust, & Balance
Date: 03/06/2023

PROJECT
02-27-23 CULVERS - FRANKFORT, IN

Project: 02-27-23 CULVERS - FRANKFORT, IN

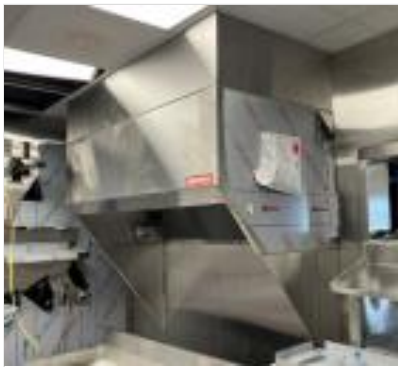
HOOD 1

Notes: HMI FOR HOODS IS DEFECTIVE AND NEEDS TO BE REPLACED. TECH CANNOT ADJUST SPEEDS OF THE UNITS UNTIL THEN. BASED ON FAN LAW, TECH DETERMINED THAT THE SPEED WILL NEED TO BE DECREASED TO 38.7HZ ON THE HMI.

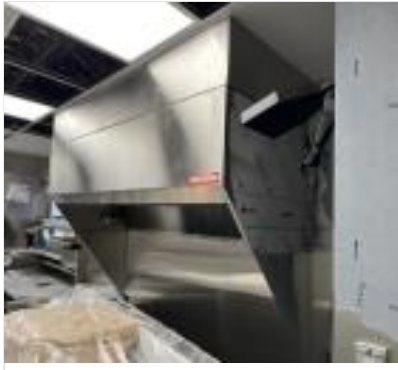
HOOD 2

Notes: HMI FOR HOODS IS DEFECTIVE AND NEEDS TO BE REPLACED. TECH CANNOT ADJUST SPEEDS OF THE UNITS UNTIL THEN. BASED ON FAN LAW, TECH DETERMINED THAT THE SPEED NEEDS TO BE DECREASED TO 36.3HZ TO BE IN DESIGN.
