**Report: TAB REPORT
Function: Test, Adjust, & Balance
Date: 02/21/2023**

**PROJECT
02-20-23 FREDDY'S - BELLEVILLE, IL**

**Freddy's Frozen Custard & Steakburgers (CORPORATE)
260 N Rock Rd
Suite 200
Wichita, KS 67206**

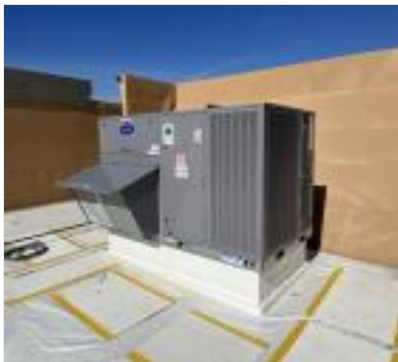
Description : RTU-1 still has throwaway construction filters installed. Recommend correct final filters are installed at turnover.
