**Report: TAB**

**Function: Test, Adjust, & Balance**

**Date: 07/16/2025**

## 07-14-25 FREDDY'S DENTON, TX

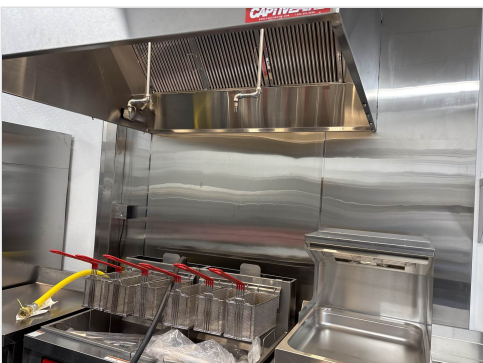
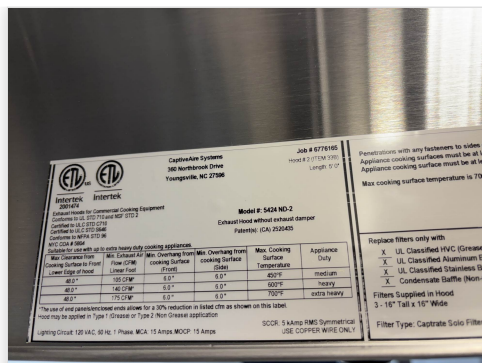
<b>Quarter or full vertical end panels are installed if specified?</b>	Fail
--	------

Smoke test for the fryer fails due to lack of side/end panel.
