Report: TAB PRACTICE

Function: Test, Adjust, & Balance

07-14-25 FREDDY'S DENTON, TX

KT Ventures

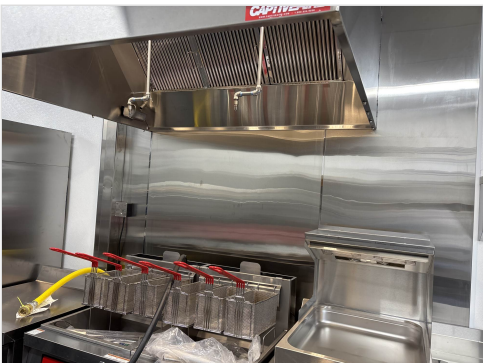
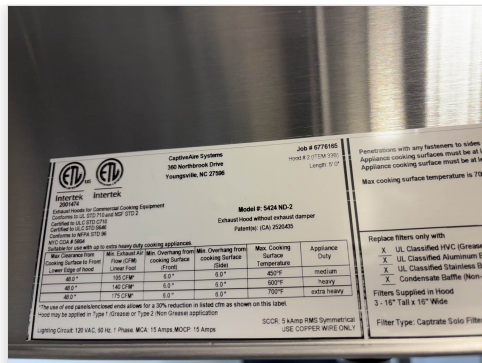
Issue Name : No End/Side Panels
Description : Currently there are no end/panels or side panels installed, so smoke captures fails.
Created By : National TAB **Assigned To :** National TAB - Cavin Van
Status : Open
Priority : Medium **Asset Tag :**
Originated Date : 07/16/2025 - Cavin Van - National TAB

Quarter or full vertical end panels are installed if specified?	Fail
--	------

Smoke test for the fryer fails due to lack of side/end panel.

Cooking Equipment	
	Actual
Item 1	FRYER
Item 2	FRY HOLDING STATION
