Report: TAB Survey
Function: Test, Adjust, & Balance
Date: 11/19/2025
Completed By: National TAB

09-01-25 BOJANGLES #1264 MARIETTA, GA

Budderfly

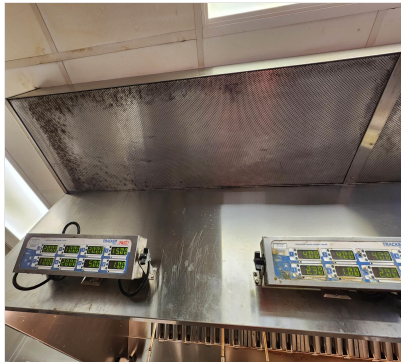
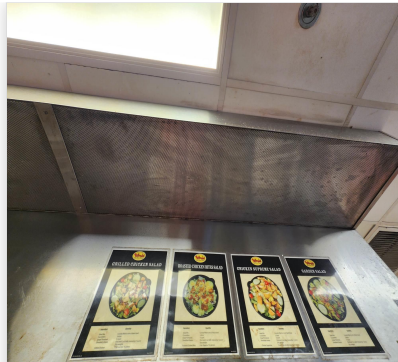
MUA plenum

Is the MUA discharge plenum clean and not clogged? If there is a PSP shine a light into the perforated metal and see if the top layer appears to be clogged Fail

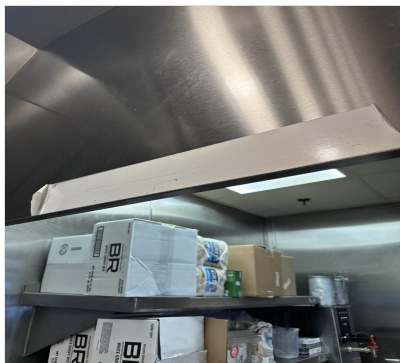
Label Faded
