**National TAB
1329 E. KEMPER ROAD
SUITE 4210
CINCINNATI, OH 45246**

**Report: TAB REPORT
Function: Test, Adjust, & Balance
Date: 11/11/2022**

**PROJECT
11-07 CULVERS - SPARTA, WI**

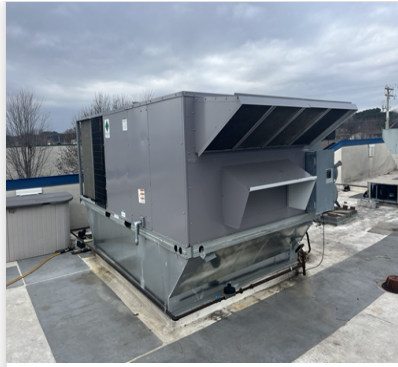
RTU-2 (Kitchen)

Issue Name : RESOLVED: RTU-2 Condensate drain not installed
Description : Condensate drain was found damage and broken on roof. Recommend replacement.
Created By : National TAB **Assigned To :** National TAB - Michael McDonnell
Status : Closed
Originated Date : 11/10/2022 - Michael McDonnell - National TAB

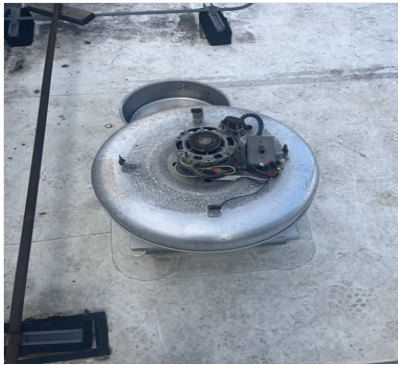
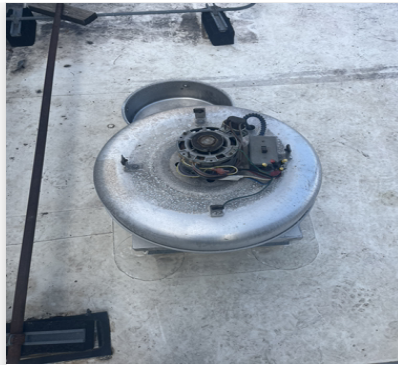
PRV-1 (Restroom)

Description : PRV-1 was not operating on arrival. Fan has power on the roof but was not rotating and motor was hot to the touch. Motor likely needs replacement. Turned off at the roof disconnect.

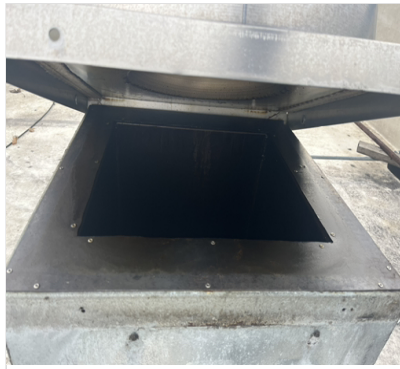
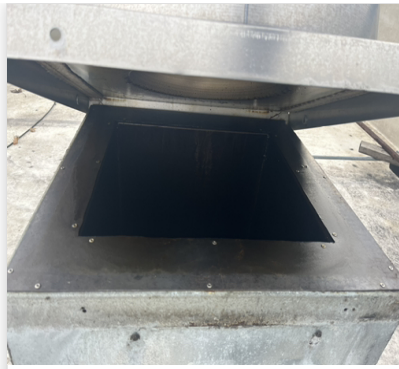
PRV-2 (Griddle)

Description : PRV-2 is wired to the incorrect contactor with lower amperage rating and causing the fan to trip above 4amps. Motor is rated for 5.9 amps. PRV-3, with lower motor amperage rating, is wired to the higher rated contactor (8amps). Recommend swapping contactors so PRV-2 can be set to design airflow.

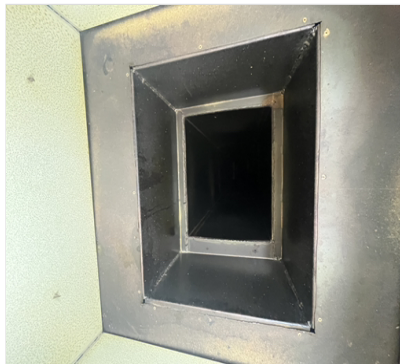
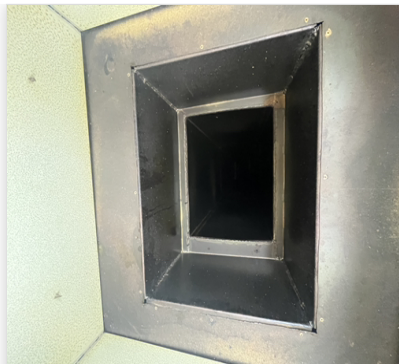
PRV-3 (Fryer)

Issue Name : 3. PRV-3 (fryer) needs belt replacement.

Description : Belt is cracked and worn, recommend replacement. Belt size installed is AP23.
