**Report: TAB REPORT  
Function: Test, Adjust, & Balance  
Date: 11/11/2022**

**PROJECT  
11-07 CULVERS - SPARTA, WI**

Project: 11-07 CULVERS - SPARTA, WI

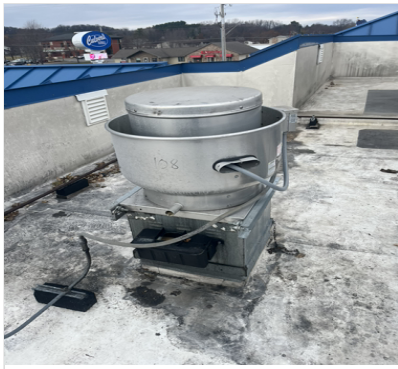
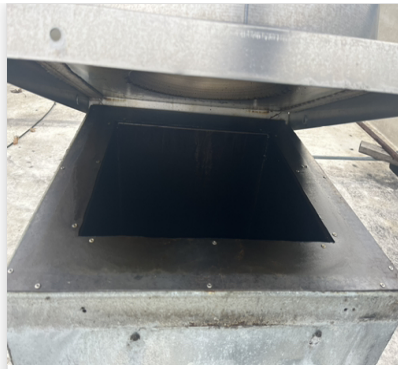
PRV-2 (Griddle)

**Description :** PRV-2 is wired to the incorrect contactor with lower amperage rating and causing the fan to trip above 4amps. Motor is rated for 5.9 amps. PRV-3, with lower motor amperage rating, is wired to the higher rated contactor (8amps). Recommend swapping contactors so PRV-2 can be set to design airflow.

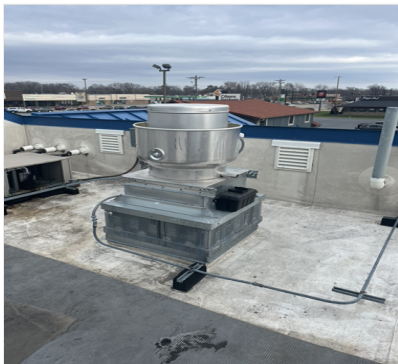
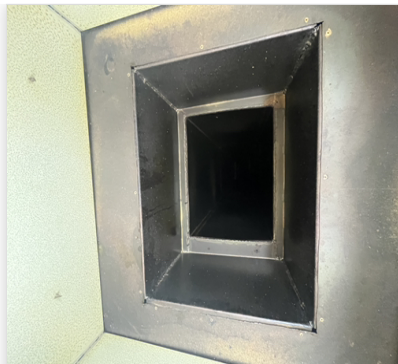
PRV-3 (Fryer)

**Issue Name :** 3. PRV-3 (fryer) needs belt replacement.

**Description :** Belt is cracked and worn, recommend replacement. Belt size installed is AP23.
