PlanGrid Task Report - Sep 9, 2024

Prepared by Stephen Tassinaro

Sep 9, 2024

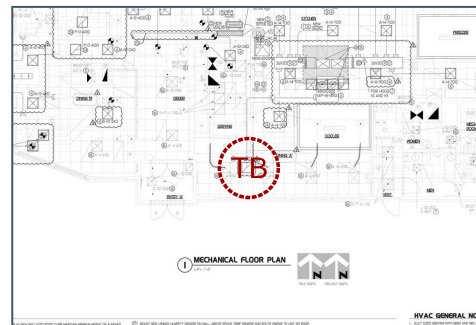
Description
Return Grille 2-1 could not be located in the space. Per M1.1 it should be located adjacent to diffusers 1-1 and 1-2 (side dining area).
*Reference NTi GRD Layout.

No change

NTi diffuser balance satisfies RFI #2 as-is. No changes required.

Satisfies RFI 11 Issue #2

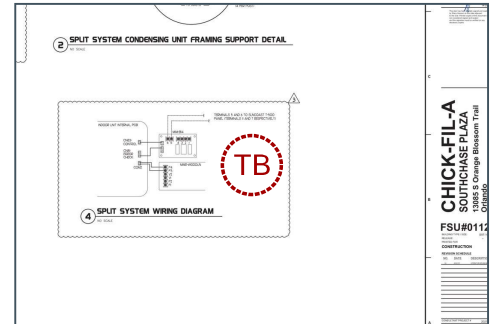
Sheet
M4.2

Description
Mini split control wires not landed in suncoast panel.

No wires landed 6/19
