# PlanGrid Task Report - Jul 15, 2025

Prepared by Michael McDonnell

Jul 15, 2025

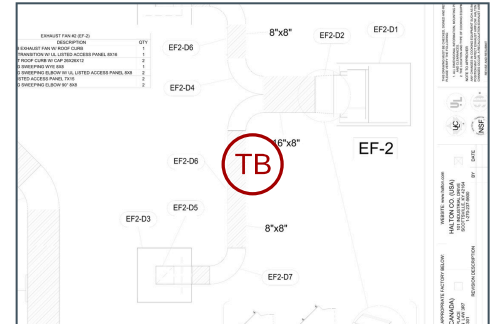
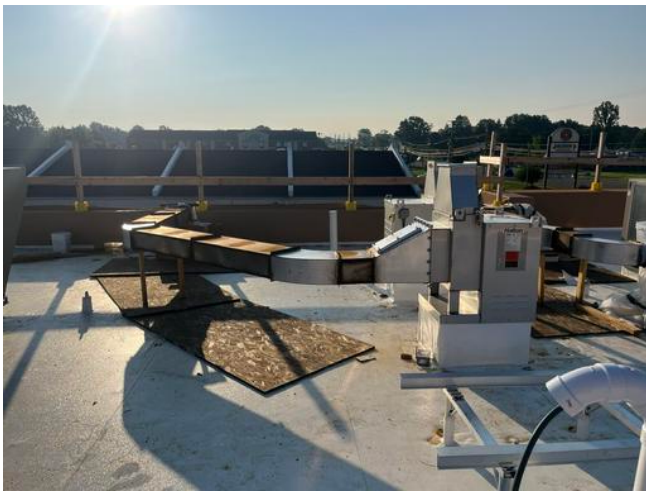
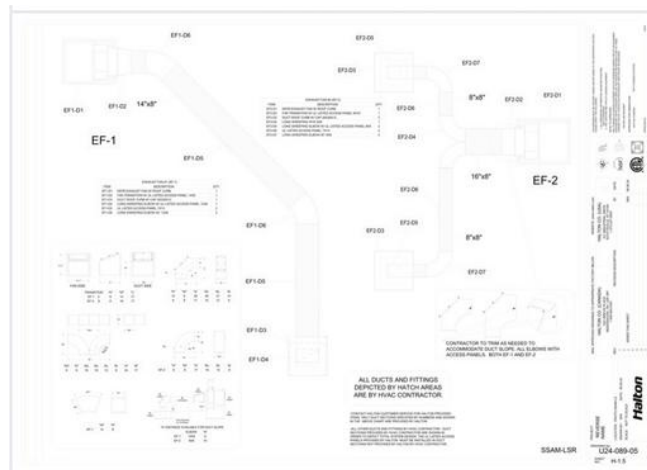
**Sheet**  
MH-1.5

Installation in progress.  
 Refer to H-1.5 for cleanout door quantity, location, and type. Review Exhaust fan specs on M-501 for duct support stand specifications, G2 drip guard, etc.

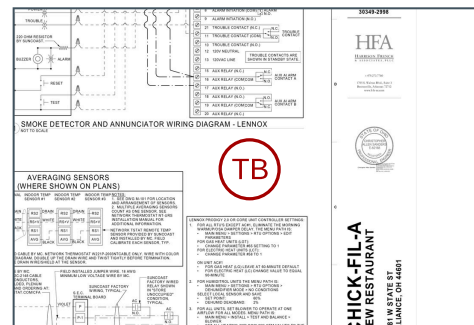
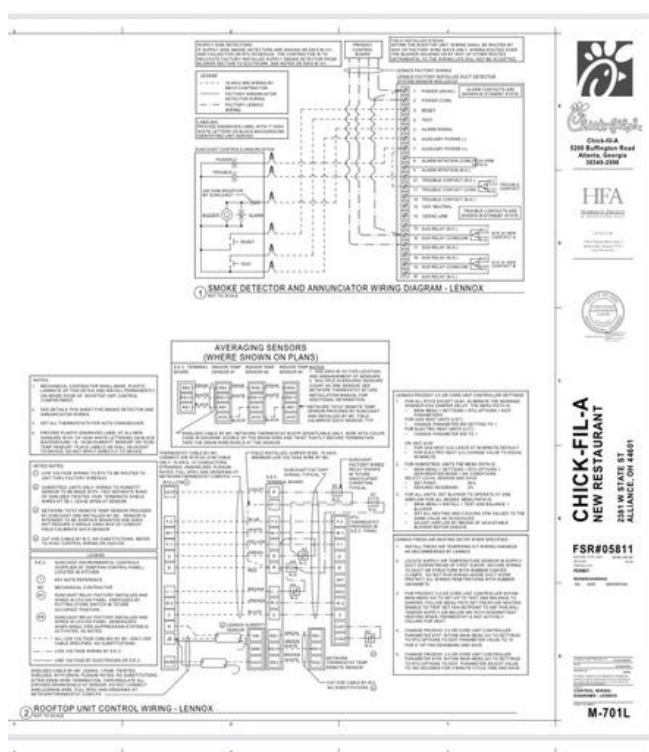
Sheet  
M-701L

Control wiring in progress. Recommend M-701L is reviewed for control wiring specifications. Please note label requirements for annunciators and all sensors.

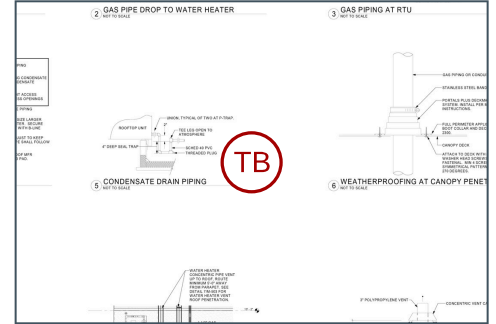
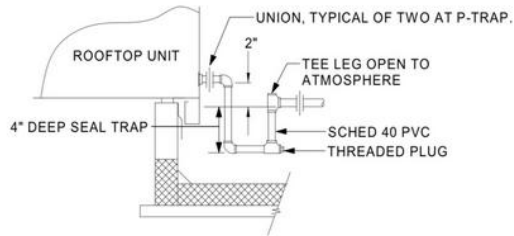
**5 CONDENSATE DRAIN PIPING**  
NOT TO SCALE

AC unit condensate drains are not yet installed. See detail 5 on M-503 for exact specifications.
