National TAB  
1329 E. KEMPER ROAD  
SUITE 4210  
CINCINNATI, OH 45246

**Report: TAB REPORT**  
**Function: Test, Adjust, & Balance**  
**Date: 11/07/2024**  
**Completed By: National TAB**

**11-04-24 CHIPOTLE #5453 MINNEAPOLIS,  
MN (DINKYTOWN)**

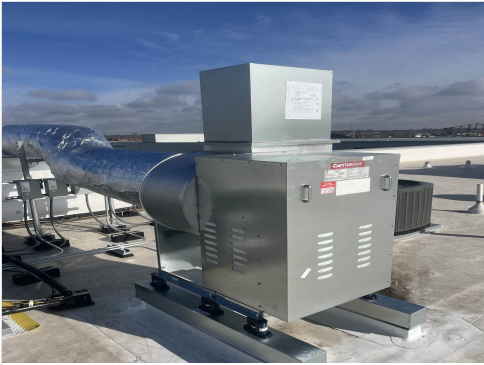
IMG\_2010\_237474374.jp..

[1] EXHAUST ABOVE DESIGN AIRFLOW. NO SPEED CONTROL SPECIFIED OR INSTALLED. NOT ANTICIPATED TO CAUSE ANY ISSUE.
