National TAB
1329 E. KEMPER ROAD
SUITE 4210
CINCINNATI, OH 45246

Report: TAB REPORT
Function: Test, Adjust, & Balance
Date: 05/31/2023

PROJECT
05-29-23 CULVERS - GRAIN VALLEY, MO

Captive-Aire Region #60

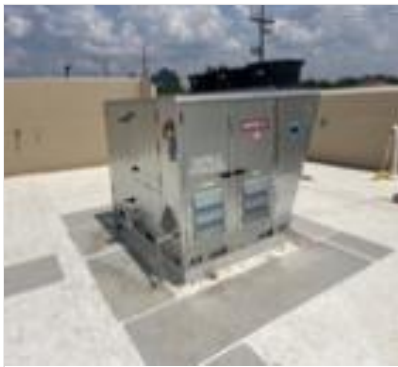
RTU2
05/24/2023

Issue Name : 1. RTU-2 Supply Airflow Low
Description : RTU2 is low on supply airflow at 5573 / 6225 cfm due to leakage from unsealed ductwork. The solid duct around many of the diffusers is not sealed and air is escaping above ceiling as a result. Some of the takeoffs and solid duct zip ties are loose as well. These ducts need to be sealed and flex needs to be checked to make sure it stays attached.
Created By : National TAB **Assigned To :** National TAB - Jacob Davidson
Status : Open
Originated Date : 05/23/2023 - Jacob Davidson - National TAB

Notes: MOTOR SETPOINT: 57.0 HZ [1] UNIT IS LOW ON FLOW DUE TO DUCT LEAKAGE, SEE ISSUE. DIFFUSERS WERE BALANCED FOR HOOD SMOKE CAPTURE PERFORMANCE AND COMFORT.
