**National TAB
1329 E. KEMPER ROAD
SUITE 4210
CINCINNATI, OH 45246**

**Report: TAB REPORT
Function: Test, Adjust, & Balance
Date: 05/31/2023**

**PROJECT
05-29-23 CULVERS - GRAIN VALLEY, MO**

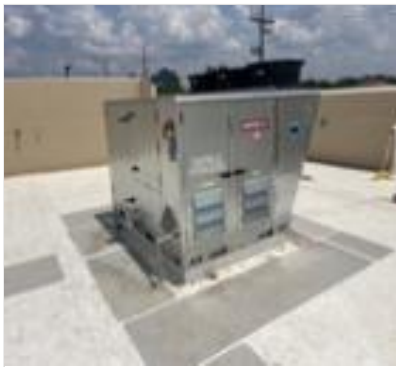
RTU2
05/24/2023

Issue Name : RTU2 low flow, solid duct not sealed
Description : RTU2 is low on flow at 5573 of 6225. The solid duct around many of the diffusers is not sealed and air is escaping above ceiling as a result. Some of the takeoffs and solid duct zip ties are loose as well. These ducts need to be sealed and flex needs to be checked to make sure it stays attached.
Created By : National TAB **Assigned To :** National TAB - Jacob Davidson
Status : Open
Originated Date : 05/23/2023 - Jacob Davidson - National TAB

Notes: SPEED SETPOINT: 57.0 HZ UNIT IS LOW ON FLOW DUE TO DUCT LEAKAGE. DIFFUSERS WERE BALANCED FOR SMOKE CAPTURE PERFORMANCE AND COMFORT.

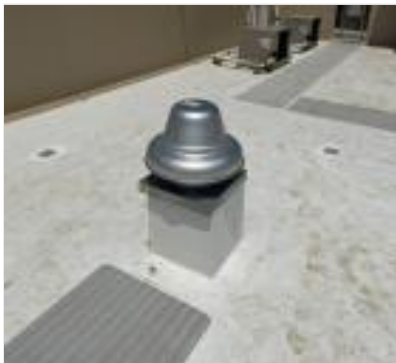
PRV1
05/24/2023

Issue Name : PRV1 no backdraft damper installed
Description : INFO ONLY: PRV1 does not have a backdraft damper which is required for restroom exhaust fans. This does not affect the scope of the tab
Created By : National TAB **Assigned To :** National TAB - Jacob Davidson
Status : Open
Originated Date : 05/22/2023 - Jacob Davidson - National TAB
