National TAB  
1329 E. KEMPER ROAD  
SUITE 4210  
CINCINNATI, OH 45246

**Report: TAB REPORT**  
**Function: Test, Adjust, & Balance**  
**Date: 05/31/2023**

**PROJECT**  
**05-29-23 CULVERS - GRAIN VALLEY, MO**

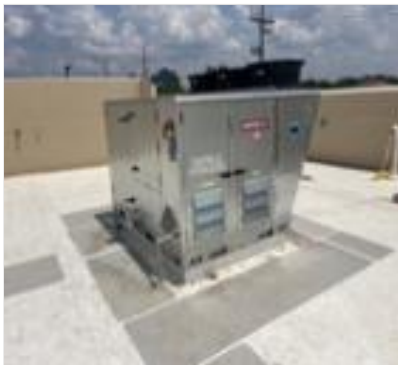
**RTU2**  
**05/24/2023**

**Issue Name :** 1. RTU-2 Supply Airflow Low  
**Description :** RTU2 is low on supply airflow at 5573 / 6225 cfm due to leakage from unsealed ductwork. The solid duct around many of the diffusers is not sealed and air is escaping above ceiling as a result. Some of the takeoffs and solid duct zip ties are loose as well. These ducts need to be sealed and flex needs to be checked to make sure it stays attached.  
**Created By :** National TAB                      **Assigned To :** National TAB - Jacob Davidson  
**Status :** Open  
**Originated Date :** 05/23/2023 - Jacob Davidson - National TAB

Notes: MOTOR SETPOINT: 57.0 HZ [1] UNIT IS LOW ON FLOW DUE TO DUCT LEAKAGE, SEE ISSUE. DIFFUSERS WERE BALANCED FOR HOOD SMOKE CAPTURE PERFORMANCE AND COMFORT.

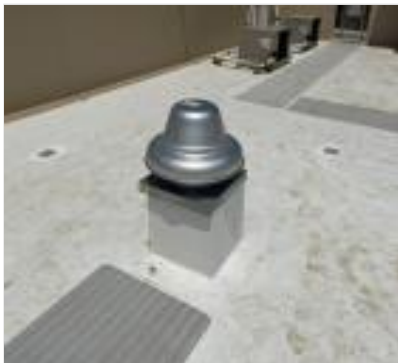
**PRV1**  
**05/24/2023**

**Issue Name :** 5. PRV-1 No Backdraft Damper Installed  
**Description :** PRV1 does not have a backdraft damper which is required for restroom exhaust fans. Recommend damper is installed. This does not affect the scope of the tab  
**Created By :** National TAB **Assigned To :** National TAB - Jacob Davidson  
**Status :** Open  
**Originated Date :** 05/22/2023 - Jacob Davidson - National TAB

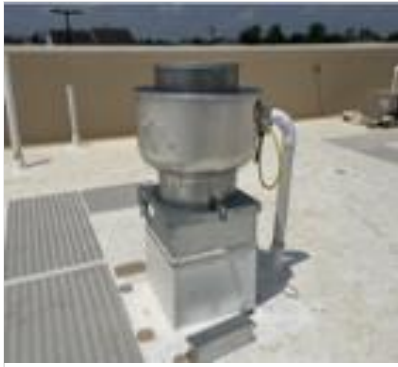
**PRV2**  
**05/24/2023**

**Issue Name :** 6. PRV-2 and PRV-3 Grease Cups Not Installed  
**Description :** Grease capture cups are not installed on either PRV2 or PRV3. In addition, the hinge kit on PRV3 is supposed to be installed opposite of the grease spout and is installed to the side of it. Recommend this is corrected. This will not impact TAB.  
**Created By :** National TAB                      **Assigned To :** National TAB - Jacob Davidson  
**Status :** Open  
**Originated Date :** 05/22/2023 - Jacob Davidson - National TAB

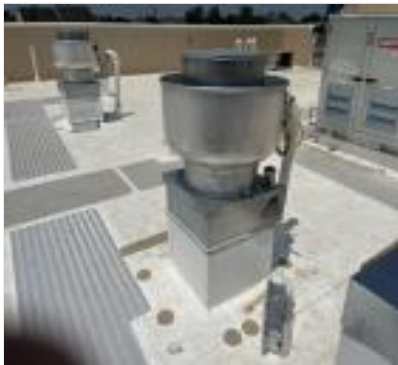
**PRV3**  
**05/24/2023**

**Issue Name :** 4. PRV-3 Hinge Kit Orientation  
**Description :** PRV3 hinge kit is installed on the same side as the conduit pipe, preventing the fan from leaning back. This will inhibit/prevent proper grease duct cleaning. Recommend hinge location is corrected. Static pressure could not be measured as a result.  
**Created By :** National TAB                      **Assigned To :** National TAB - Jacob Davidson  
**Status :** Open  
**Originated Date :** 05/22/2023 - Jacob Davidson - National TAB
