**Report: TAB Report**  
**Function: Test, Adjust, & Balance**  
**Date: 03/27/2024**

**PROJECT**  
**04-01-24 CULVERS-ARCADIA, FL**

Project: 04-01-24 CULVERS-ARCADIA, FL

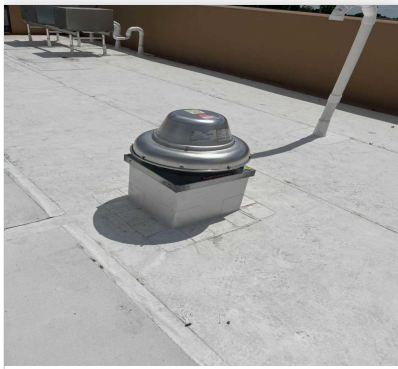
**PRV1**  
**03/27/2024**

**Issue Name :** PRV-1 No Backdraft Damper  
**Description :** There is no backdraft damper installed in the PRV-1 duct. Recommend installing. MC INSTALLED DURING TAB.  
**Created By :** National TAB                      **Assigned To :** National TAB - Stephen Tassinaro  
**Status :** Closed  
**Priority :** [Medium](#)                      **Asset Tag :**  
**Originated Date :** 03/25/2024 - Stephen Tassinaro - National TAB
