**Report: TAB REPORT  
Function: Test, Adjust, & Balance  
Date: 01/30/2024**

## **12-25-23 MEZEH HAMILTON TOWNSHIP, NJ**

209 Marketplace Boulevard Block 2613, Lot 38

**Mezeh Mediterranean Grill  
3975 FAIR RIDE DR  
SUITE 430  
FAIRFAX, VA 22033**

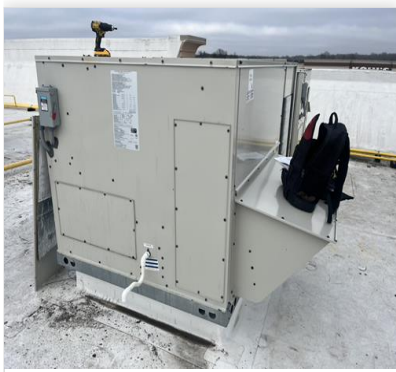
**RTU-1(1)**  
**01/30/2024**

**Issue Name :** Missing filters for RTU-1  
**Description :** RTU-1 is missing 2 filters. Recommend installing filters prior to sites opening.  
**Created By :** National TAB                      **Assigned To :** National TAB - David Annan  
**Status :** Open  
**Priority :**                                              **Asset Tag :**  
**Originated Date :** 01/30/2024 - David Annan - National TAB
