National TAB  
1329 E. KEMPER ROAD  
SUITE 4210  
CINCINNATI, OH 45246

**Report: TAB REPORT**  
**Function: Test, Adjust, & Balance**  
**Date: 01/30/2024**

**12-25-23 MEZEH HAMILTON TOWNSHIP, NJ**

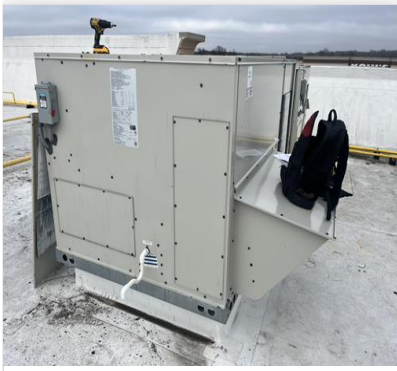
**RTU-1(1)**  
**01/30/2024**

**Issue Name :** Missing filters for RTU-1  
**Description :** RTU-1 is missing 2 filters. Recommend installing filters prior to sites opening.  
**Created By :** National TAB                      **Assigned To :** National TAB - David Annan  
**Status :** Open  
**Priority :** Medium                                      **Asset Tag :** RTU1  
**Originated Date :** 01/30/2024 - David Annan - National TAB

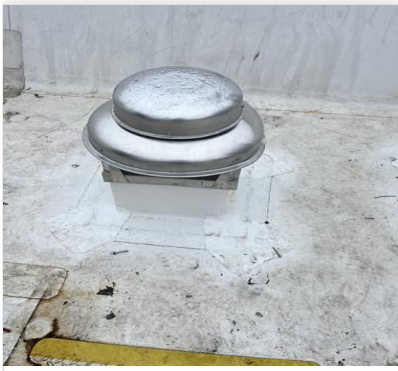
**EF-5**  
**01/30/2024**

The fan is already running at the highest fan speed setting.
