Report: TAB Report
Function: Test, Adjust, & Balance
Date: 07/03/2024

06-24-24 WAWA #5413 SARASOTA, FL

Project: 06-24-24 WAWA #5413 SARASOTA, FL

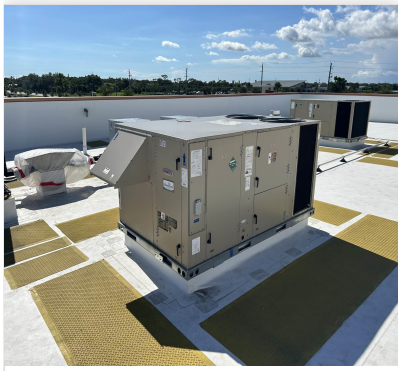
RTU-1

Issue Name : RTU 1 - compressor 1 fault
Description : RTU 1 has a persistent error on the CORE interface, stating that compressor 1 is not running as intended. Recommend inspecting compressor for possible damage.
Created By : National TAB **Assigned To :** National TAB - Mark Johnson
Status : Open
Priority : High **Asset Tag :**
Originated Date : 06/26/2024 - Mark Johnson - National TAB

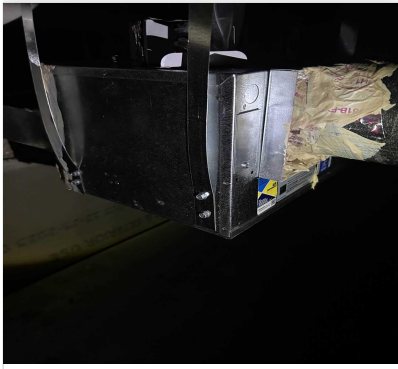
Issue Name : EF-2 low flow
Description : EF-2 is experiencing low exhaust flow (22 CFM, 37% of design) after installation of speed controller. Additionally, the fan is starting and stopping at frequent intervals. Fan is set to max speed. Recommend checking speed controller and wiring for possible faults.
