**Report: TAB Report**  
**Function: Test, Adjust, & Balance**  
**Date: 06/27/2024**

**PROJECT**  
**06-24-24 WAWA #5413 SARASOTA, FL**

Project: 06-24-24 WAWA #5413 SARASOTA, FL

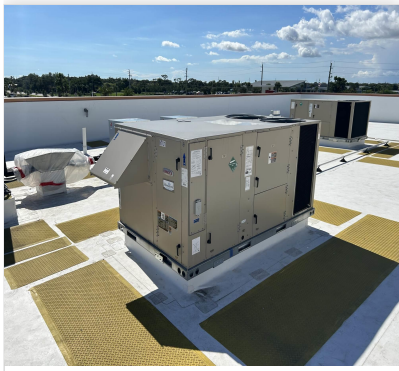
**RTU-1**

**Issue Name :** RTU 1 - compressor 1 fault  
**Description :** RTU 1 has a persistent error on the CORE interface, stating that compressor 1 is not running as intended. Recommend inspecting compressor for possible damage.  
**Created By :** National TAB                      **Assigned To :** National TAB - Mark Johnson  
**Status :** Open  
**Priority :** High                                      **Asset Tag :**  
**Originated Date :** 06/26/2024 - Mark Johnson - National TAB
