# PlanGrid Task Report - Aug 30, 2024

**L05622\_Marion (IL) FSU**

2820 Joseph Cannon Way, Marion, Illinois

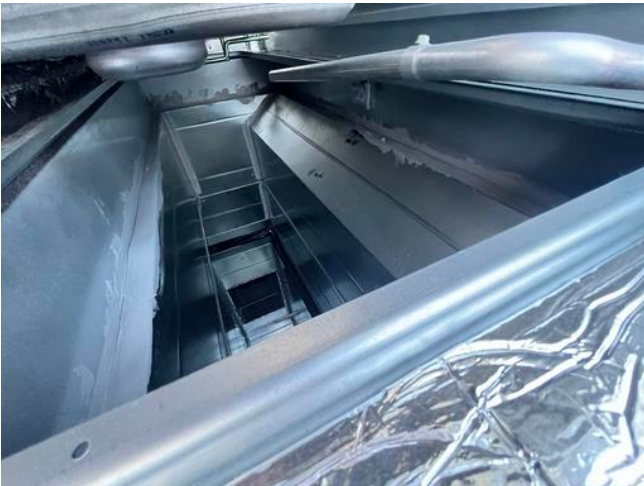
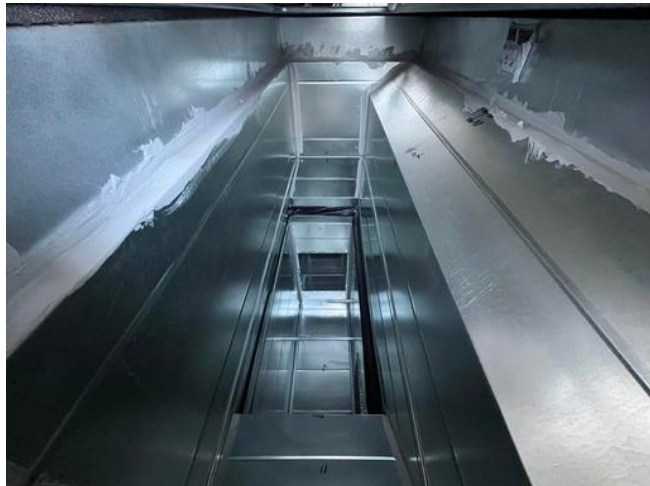
AC-3 supply drop does not meet specifications. See note 48 on M-101. No turning vanes installed, drop does not meet radius specification, takeoff location repositioned. Unit achieving design supply airflow. Critical Issue, Seek approval.
