Report: TAB Report
Function: Test, Adjust, & Balance
Date: 11/26/2025
Completed By: National TAB

PROJECT
12-08-25 QT #1439 MESA, AZ

Project: 12-08-25 QT #1439 MESA, AZ

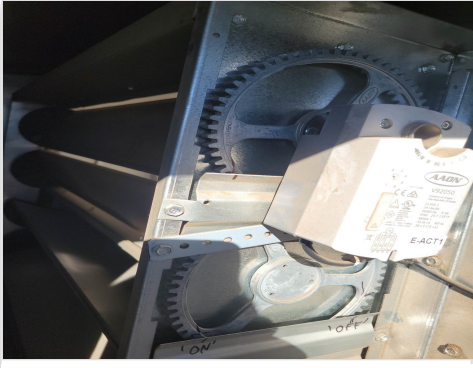
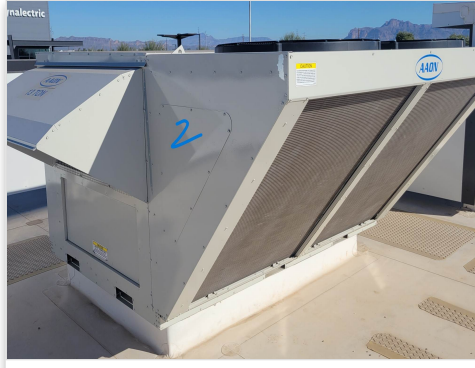
WOMEN'S BATHROOM AIRFLOW EXTREMELY LOW. HVAC SHOULD LOOK INTO CAUSE. DAMPER INACCESSIBLE DUE TO SHELVES.

UNIT PRESSURES ARE PRETTY HIGH, SOME REGISTERS READ LOW, AND UNITS ARE RUNNING AT MAX - RECOMMEND HVAC CHECK ALL DAMPERS/DUCT FOR RTU1&2.
