Report: TAB REPORT
Function: Test, Adjust, & Balance
Date: 12/19/2024
Completed By: National TAB

PROJECT
12-16-24 CULVERS SAUK CITY, WI

Project: 12-16-24 CULVERS SAUK CITY, WI

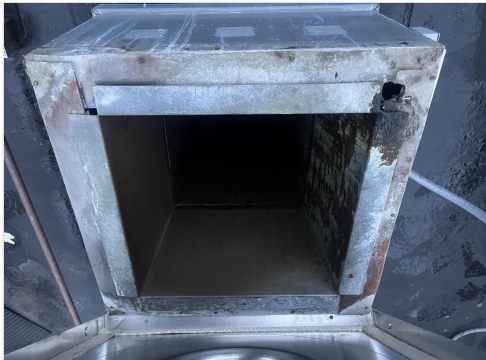
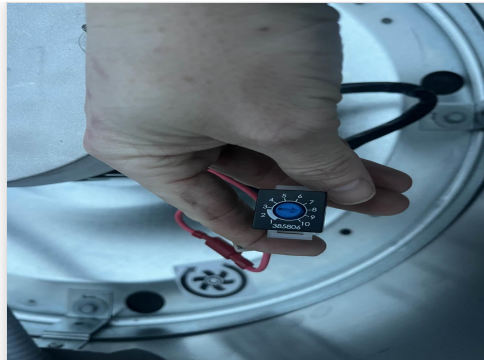
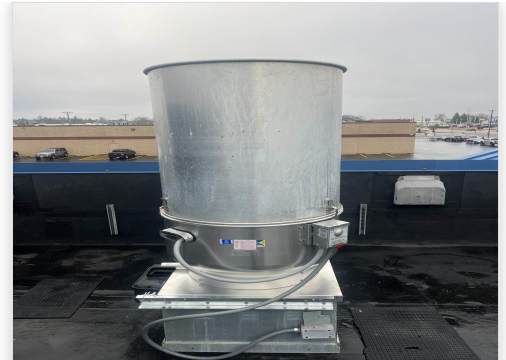
- [1] UNIT INSTALLED ON CURB ADAPTER
- [2] EVAPORATOR COIL IN NEED OF CLEANING
- [3] ONLY 3 DIFFUSERS ON COOKLINE WITH HIGH AIRFLOW. RECOMMEND ADDITIONAL DIFFUSERS ADDED BETWEEN HOODS-SHOULD IMPROVE CAPTURE ON HD-2.
- [4] UNIT AT 327 CFM/TON-MOTOR OPERATING AT FLA.

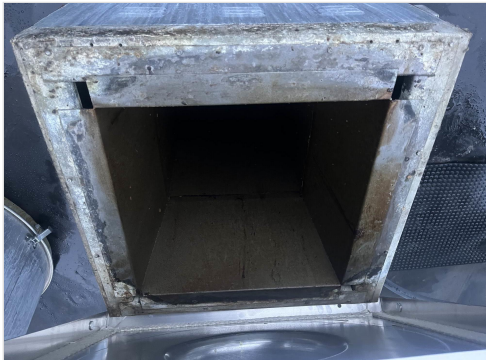
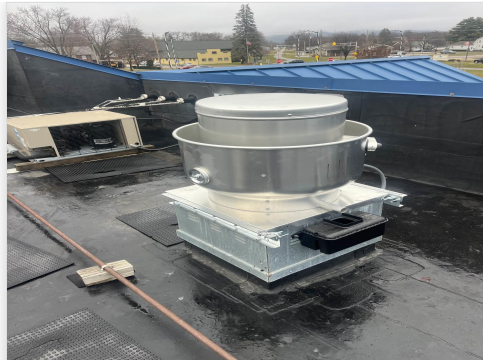
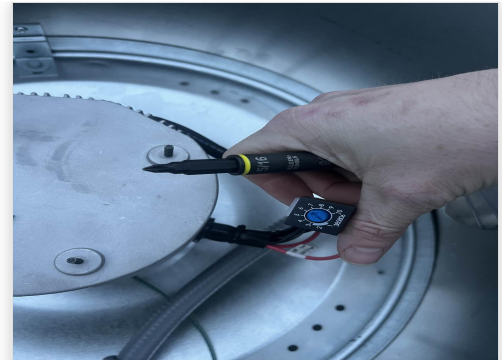
[1] FAN SERVES BOTH CUSTOMER RR AND EMPLOYEE RR. CUSTOMER RR AT APPROPRIATE FLOW FOR NEGATIVE SPACE. EMPLOYEE RR HIGH ON EXHAUST (220CFM), NOT ANTICIPATED TO CAUSE ANY ISSUE.

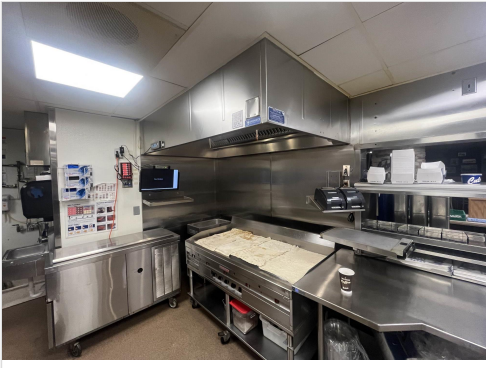
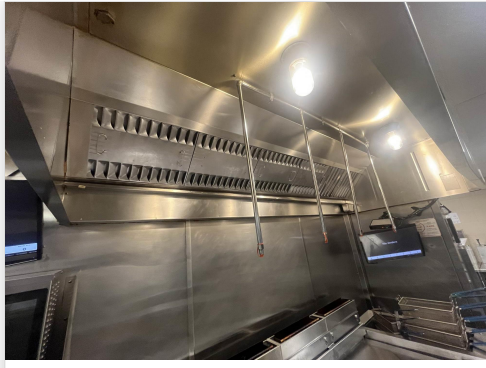
[1] MAU IS CONDITIONED AND CONTROLLED VIA THERMOSTAT IN OFFICE. SERVES 3 GRILLES IN BOH.
