**Report: RENEW - 1122
Function: Test, Adjust, & Balance
Date: 11/09/2022**

**PROJECT
09-12 FIVE GUYS #1840 - THORTON, CO
(RENEW)**

14326 LINCOLN ST
THORNTON, CO 80233

Name : 5 GUYS HVAC PERFORMANCE EVALUATION **Status :** NotSubmitted
Assigned Organization : National TAB **Asset :**
Requesting Organization : National TAB

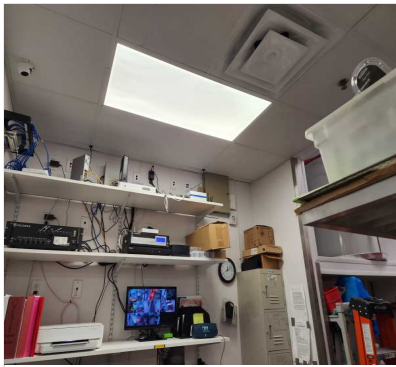
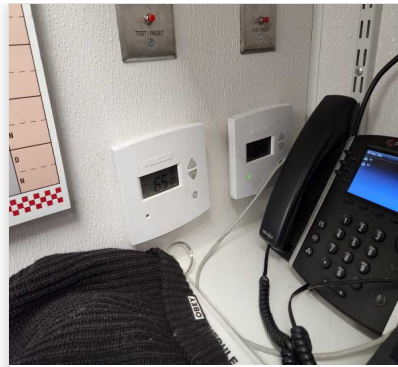
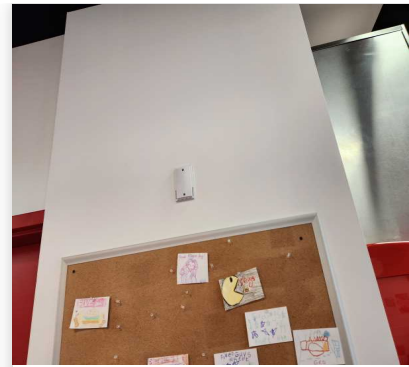
TAKE PICTURE OF THERMOSTATS AND WALL SENSORS

ARE THERMOSTATS PROGRAMMED FOR OCCUPIED HOURS AND IS THE FAN IN "ON" MODE DURING OCCUPIED TIMES

YES
