## GSA DC0021ZZ Central Office Headquarters (Washington, DC)

**AHU Measurement NOVA Third Party Contractor Fill Out. Measure and verify the building minimum and maximum outdoor air for each AHU providing outdoor air to the building.**

**GSA\_HQ\_OAHU-S1**

**Monday, December 13, 2021**

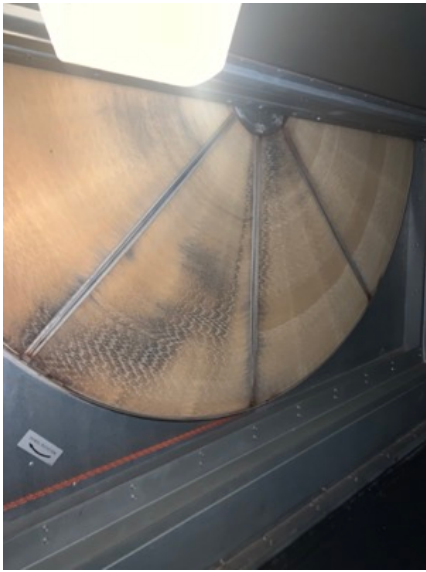
HEATING WHEEL  
There is a little bit of damage

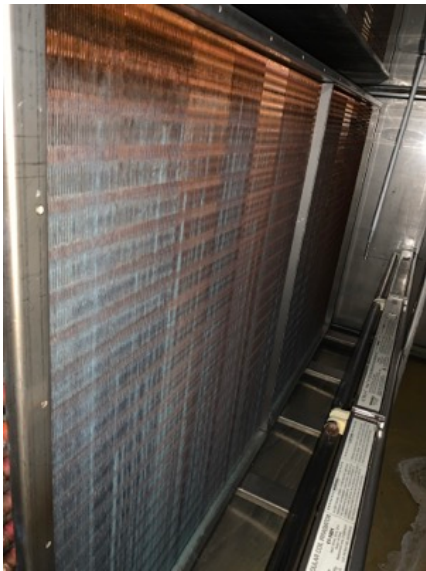
Cooling Coil(s) - Visual assessment and photo documentation.	BACK SIDE OF COOLING COIL 1 HAS OXIDATION. FRONT SIDE OF COOLING COIL 2 HAS SOME RUST ON THE FLOOR WHERE THE CONDENSATE PAN IS. BACK SIDE OF COIL 2 HAS BENT FINS
Condensate Pan(s) - Visual assessment and photo documentation.	CONDENSATE PAN IS FREE OF DEBRIS. THERE IS SOME RUST FORMING NEAR COOLING COIL 2
Any unusual operation observed? (including vibration, over-pressure, etc.)	THERE IS NO UNUSUAL OPERATION

OXIDATION ON COIL

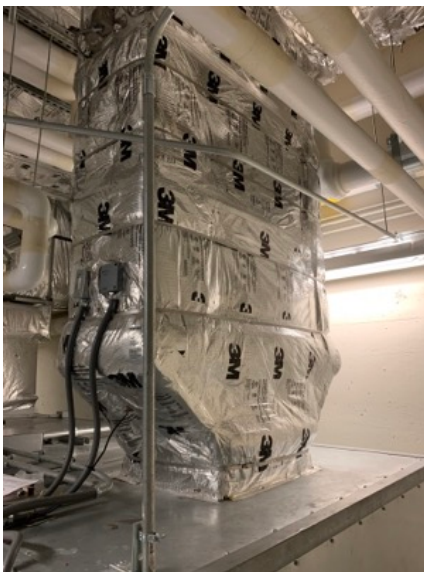
THE WINDOW IN THE RETURN PLENUM DOOR HAS A BROKEN/MISSING PANE OF GLASS. THE REMAINING PANE DOES NOT HAVE ANY LEAKAGE. WHEN THE UNIT IS IN UNOCCUPIED MODE THE RETURN FAN THAT FEEDS ATE-1/2 OVERPOWERS BOTH SUPPLY FANS. SUPPLY DUCT COULD NOT BE TRAVERSED DO TO SOUND ATTENUATION NOR COULD THE RETURNS BE READ OUT, HAD TO USE THE FLOW STATION TO USE AS THE SUPPLY TOTAL

UNABLE TO TRAVERSE SUPPLY DUCT DUE TO SOUND ATTENUATION

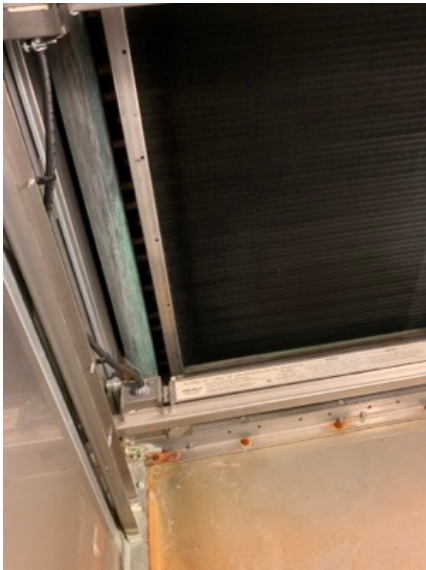
MINOR CORROSION ON COOL COIL

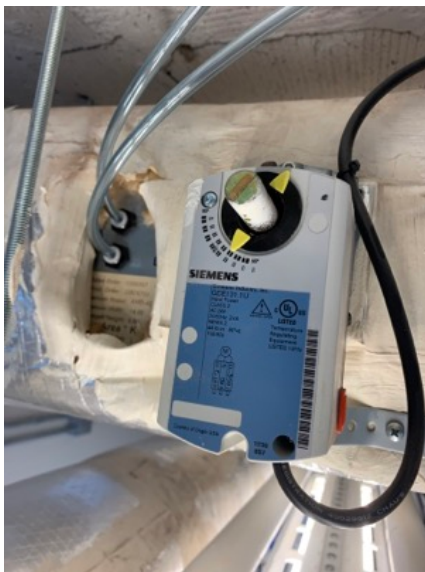
DAMPER POSITION  
APPROXIMATELY 50%

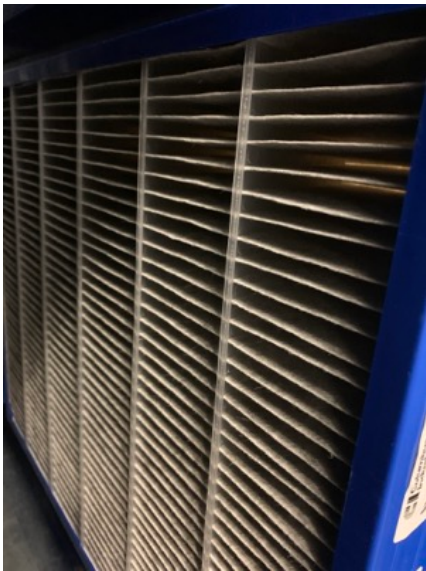
FINAL FILTER CONDITION

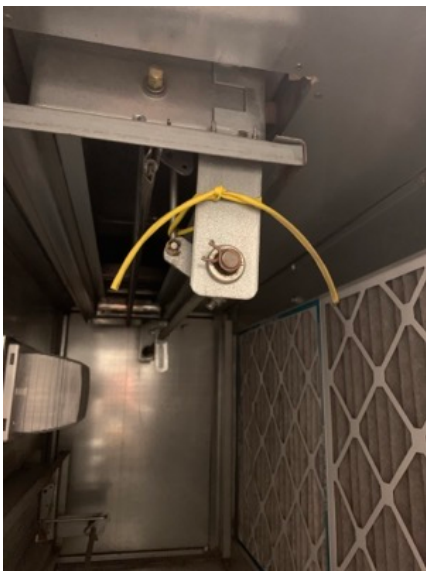
RETURN DAMPER SECURED WITH WIRE TIE
