Report: TAB Report
Function: Test, Adjust, & Balance
Date: 06/11/2024

PROJECT
06-03-24 CULVERS JACKSONVILLE, FL

Project: 06-03-24 CULVERS JACKSONVILLE, FL

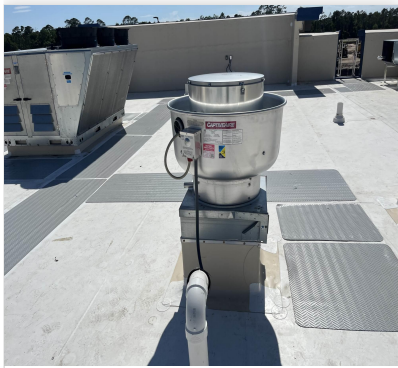
PRV-2

Issue Name : PRV 2 & 3 Curb / Hinge Assemblies
Description : PRV 2 nor PRV 3 curb caps fully secured to the curbs. The hinges and fan bases are interfering with the loose caps. Unable to measure static pressures in current conditions.
Created By : National TAB **Assigned To :** National TAB - Will Turnbough
Status : Open
Priority : Urgent **Asset Tag :**
Originated Date : 06/06/2024 - Stephen Tassinaro - National TAB

- **06/11/2024 National TAB - Stephen Tassinaro**
 - Grease cups found in motor compartments, both PRV 2 & PRV 3.

[1] CURB ASSEMBLY LOOSE. INTERFERING WITH HINGE ASSEMBLY. SEE ISSUE PICTURES.

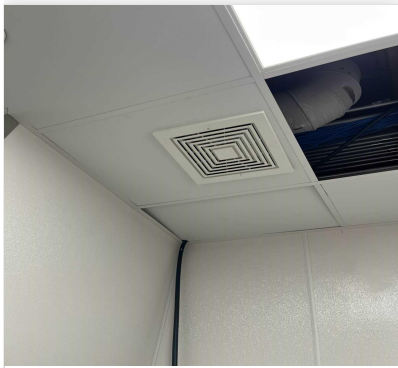
EF-1A

Issue Name : EF 1 Missing Hardware
Description : EF 1 (Mop Sink Exhaust Fan) is missing some of the hardware to attach the grille cover to the fan. Recommend sourcing and installing hardware.
Created By : National TAB **Assigned To :** National TAB - Will Turnbough
Status : Open
Priority : Low **Asset Tag :**
Originated Date : 06/03/2024 - Stephen Tassinaro - National TAB
