National TAB
1329 E. KEMPER ROAD
SUITE 4210
CINCINNATI, OH 45246

Report: TAB Report
Function: Test, Adjust, & Balance
Date: 11/19/2025
Completed By: National TAB

09-01-25 BOJANGLES #791 MARIETTA, GA

Budderfly

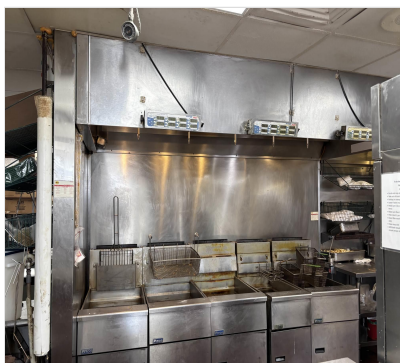
Exterior of hood zoomed out so that all kitchen equipment is visible

Are there any end panels installed on either side of the hood? Fail

Are all hood filters installed and free of damage? Fail

Do hood filters appear to be clean? Fail

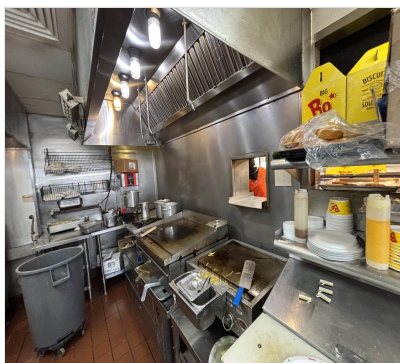
Exterior of hood zoomed out so that all kitchen equipment is visible

Are there any end panels installed on either side of the hood?	Fail
--	------

Are all hood filters installed and free of damage?	Fail
--	------

Do hood filters appear to be clean?	Fail
-------------------------------------	------

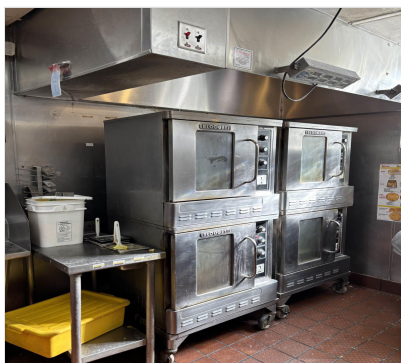
Exterior of hood zoomed out so that all kitchen equipment is visible

Are there any end panels installed on either side of the hood? Fail

Are all hood filters installed and free of damage? Fail

Do hood filters appear to be clean? Fail

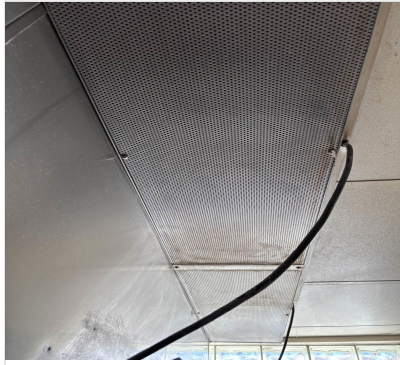
MUA plenum

Is the MUA discharge plenum clean and not clogged? If there is a PSP shine a light into the perforated metal and see if the top layer appears to be clogged Fail

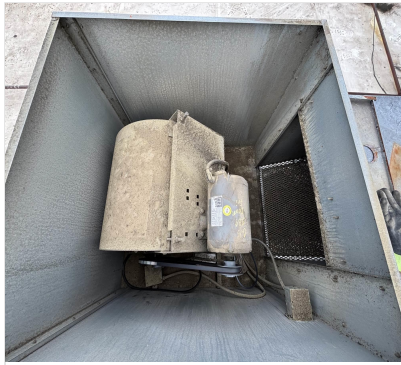
Inside of blower compartment

Blower wheel is clean and in good condition

Fail

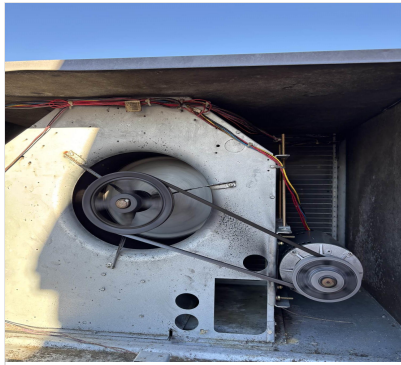
Blower compartment.

Blower wheel is clean and in good condition

Fail

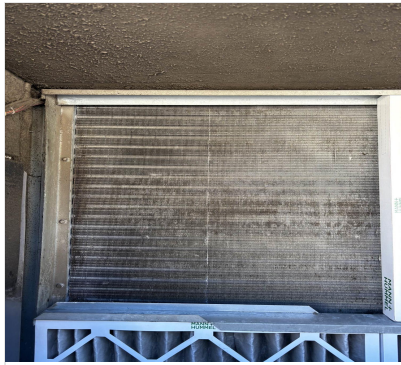
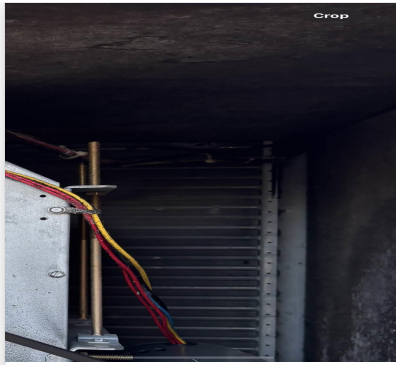
Both sides of evaporator coil

Evaporator coil is clean and in good condition

Fail
