**Report: Final Report  
Function: Test, Adjust, & Balance  
Date: 8/24/2022**

**PROJECT  
08-15 CULVERS - WHEATON, IL**

Project: 08-15 CULVERS - WHEATON, IL

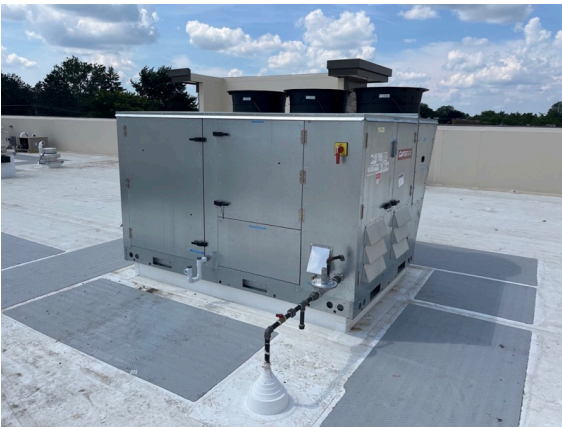
RTU-1  
Dining

**Issue Name :** RTU-1 (dining) missing return.  
**Description :** Plans call for (5) 16" returns. (4) 18" returns are installed, and not in precise locations.  
**Created By :** National TAB **Assigned To :** National TAB - Will Turnbough  
**Status :** Open  
**Originated Date :** 08/18/2022 - Michael McDonnell - National TAB

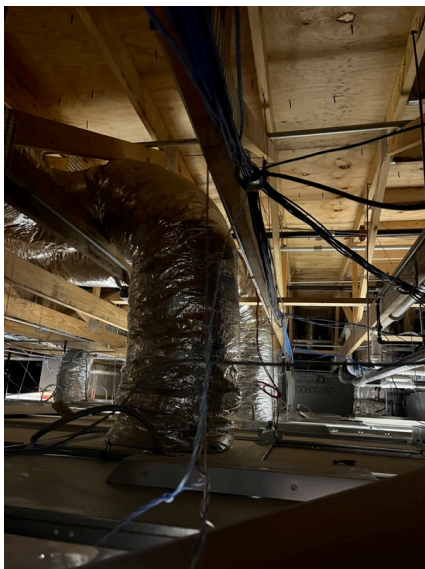
RTU-2  
Cookline diffuser drops.

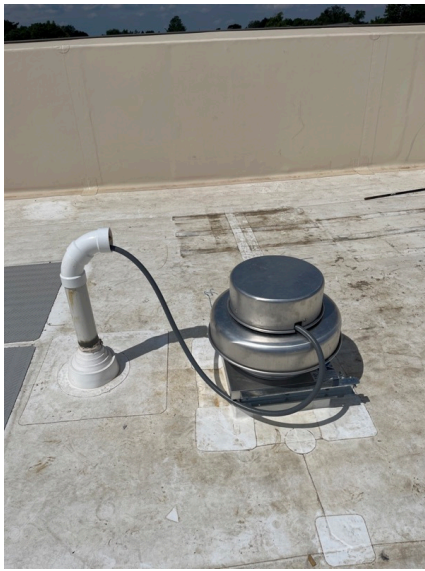
PRV-1  
Restrooms

- **08/19/2022 National TAB - Michael McDonnell**
  - Video of rotation.
    1. [Open](#) IMG7532.MOV
- **08/19/2022 National TAB - Michael McDonnell**
  - Fan not balanced. Accurex will need to send replacement motor. Per manual: motor is factory pre-wired and cannot be changed in the field.

Notes: [1] FAN NOT BALANCED DUE TO INCORRECT ROTATION. SINGLE PHASE MOTOR COMES FACTORY WIRED AND CANNOT BE CHANGED IN THE FIELD. ACCUREX IS SENDING REPLACEMENT.

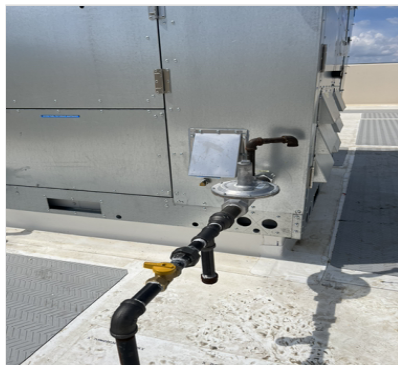
Economizers are assembled and functional?	Yes
Thermostat wire run from OCP on the RTU to the Ec terminal at the thermostat? If no, jumper can be installed from R to OCP temporarily. (The economizers will not open without OCP being energized.)	NA, Captive Aire DOAS units installed.
Motors are all operating below the FLA rating?	Yes
Are belts tight?	NA, direct drive units.
If direct drive unit is the speed controller working.	Yes
Is gas piping installed and valves turned on?	No, building does not yet have meter.
