Report: Test and Balance
Date: 11/5/2021

PROJECT
ARBY'S #5451 - OKMULGEE, OK

129 S WOOD DR
OKMULGEE, OK

REMARKS

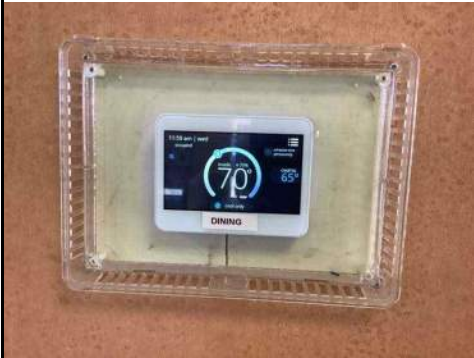
Name: Dining Room TStat.jpg Captured: 8/23/2021 10:16 AM Caption:				
8	Any Comfort issues noticed or manager statements?	Yes	Manager stated that the unit that serves the Dining room will suddenly turn off at times and she uses the breaker to turn it back on.	SC 8/11/21 12:17
9	Any significant or abnormal ventilation noise in dining or kitchen?	No		SC 8/11/21 12:18
10	Do return grilles in kitchen or dining have significant amount of dirt buildup that might impact airflow?	Yes		SC 8/11/21 12:18
Do return grilles in kitchen or dining have significant amount of dirt buildup that might impact airflow? Photo:

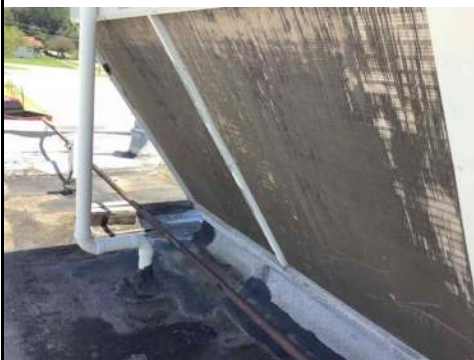
Name: Are the evaporator coils free of damage and clean?.jpg
 Captured: 8/11/2021 1:53 PM
 Caption:

8	Are the evaporator coils free of damage and clean? (Take picture)	Yes	SC	8/11/21 13:53
---	---	-----	----	---------------

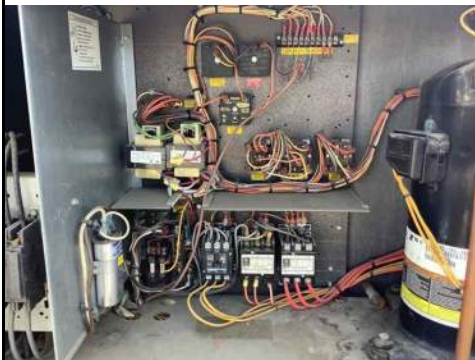
Name: Take pictures of the electrical compartment includ.jpg
 Captured: 8/11/2021 1:05 PM
 Caption:

3	Are the humidity sensors wired properly?	No	SC	8/11/21 13:32
4	If maximum damper position can be set, set to the same as the minimum damper position (if Lennox, see section at end of this checklist)	NA	SC	8/11/21 13:32
5	Final damper position is clearly marked with permanent marker or white out?	NA	SC	8/11/21 13:32
6	If damper had to be manually set and is loose, secure it with a sheet metal screw so that it cannot shut	NA	SC	8/11/21 13:32
7	LENNOX ONLY: For Honeywell Pro 8000 (TH8321R) thermostats, make sure it is set up for "Commercial", "2 Stage", and "A" terminal is wired and assigned to "Economizer".	NA	SC	8/11/21 13:32

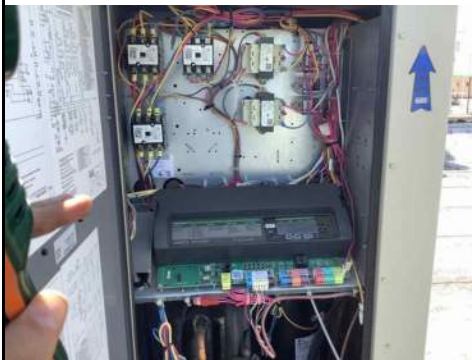
Name: Take pictures of the electrical compartment includ.jpg
 Captured: 8/11/2021 2:39 PM
 Caption:

3	Are the humidity sensors wired properly?	No	SC	8/11/21 14:39
4	If maximum damper position can be set, set to the same as the minimum damper position (if Lennox, see section at end of this checklist)	Yes	SC	8/11/21 14:41
5	Final damper position is clearly marked with permanent marker or white out?	Yes	SC	8/11/21 17:20
6	If damper had to be manually set and is loose, secure it with a sheet metal screw so that it cannot shut	NA	SC	8/11/21 14:40
7	LENNOX ONLY: For Honeywell Pro 8000 (TH8321R) thermostats, make sure it is set up for "Commercial", "2 Stage", and "A" terminal is wired and assigned to "Economizer".	NA	WC	8/16/21 13:32
