Issue List

SPCC Aseptic Training Facility (Monroe, NC)

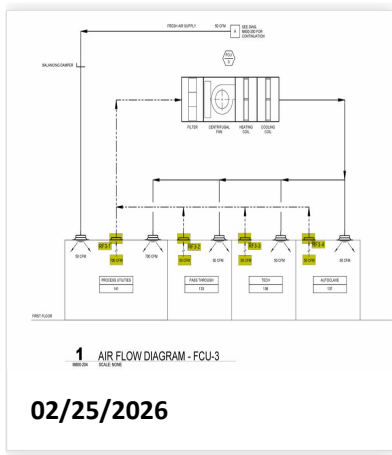
Issue Name : FCU F-3 missing damper
Description : Grille in AUTOCLAVE 137 for FCU F-3 is missing the OBD balancing damper. Also awaiting the Engineer's confirmation of increasing the grille from 50 CFM to 100 CFM, per the meeting on 2/19/2026.
Created By : National TAB
Assigned To : National TAB - Antonio Flores-De La Cruz
Status : Open
Priority : Urgent
Asset Tag :
Originated Date : 02/23/2026 - Antonio Flores-De La Cruz - National TAB

- **02/25/2026 National TAB - Antonio Flores-De La Cruz**
 - All supply and return grilles need dampers. Also, an RFI is needed to determine the new diffuser values. The actual installation does not match the design and needs clarification.
