**Report: REVIVE REPORT
Function: Test, Adjust, & Balance
Date: 01/11/2023**

**PROJECT
12-26 FREDDY'S - FAIRFAX, VA (REVIVE)**

Project: 12-26 FREDDY'S - FAIRFAX, VA (REVIVE)

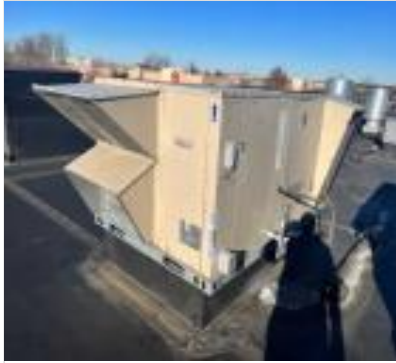
RTU-1 (Dining) airflow was found to be at 4857 CFM which is very low (240 CFM/ton). There is a high static pressure in the return duct (-1.01" wc). The outside air damper was found shut and opening up likely increased supply airflow however did not have time to re-test.

Issue Name : RTU-1 OA filter is not properly secured on unit
Description : RTU-1 outside air filter was found on the ground and not properly secured to the unit.
Created By : National TAB **Assigned To :** National TAB - David Annan
Status : Open
Originated Date : 01/03/2023 - David Annan - National TAB

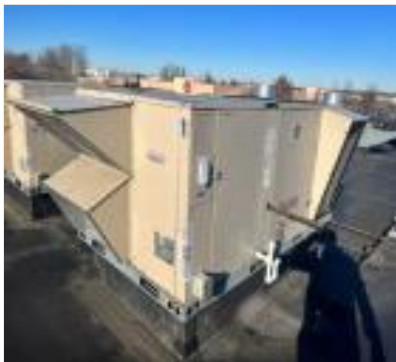
RTU-2 (Kitchen) airflow is also low. It is operating at 2720 CFM (272 CFM/ton). There appears to be room to increase the speed however there is a high static pressure in the supply duct. Did not want to increase and cause issue by further increasing the static pressure. Increasing would also cause return air to increase which can be detrimental to hood capture. Left as is but recommend investigating the restriction in the supply duct further.

Description : RTU-2 was found to have grease in the clean out door.

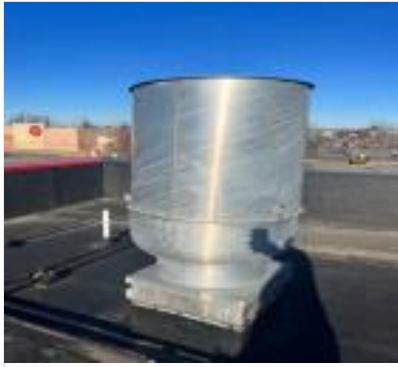
Description : EF-1 and EF-2 are running with adjustable belts. Recommend having belts replaced with proper COG belts.

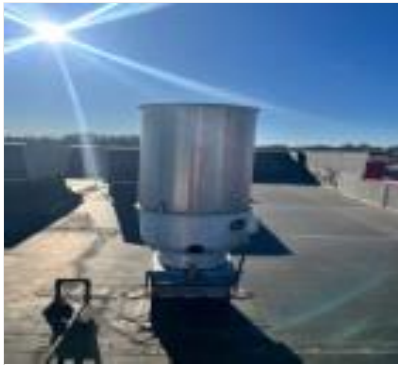
Description : EF-2 electrical disconnect was found hanging by the unit. The disconnect should be secured properly have maintenance re screw the disconnect to the unit.

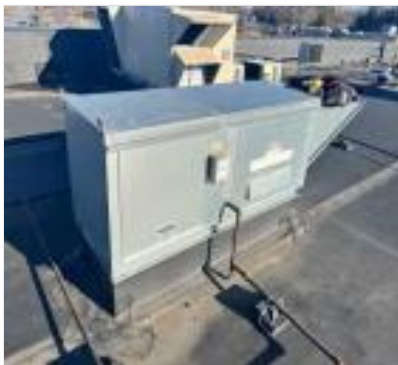
MUA-1

MUA airflow is low for the application. Appears to be due to clogged intake air filters. Recommend thoroughly cleaning or replacing the filters. There was also one leg of voltage and amperage that was measured to be low which could be affecting the motor speed.

Description : MUA outside wire filters are dirty. This affects airflow getting into the unit. Recommend having the filters cleaned.
